# VILLAGE OF PITTSFORD

## Historic and Architectural Design District Building Design Standards

# Village of Pittsford Historic and Architectural Design District Building Design Standards

Revision 1: January 17, 2010

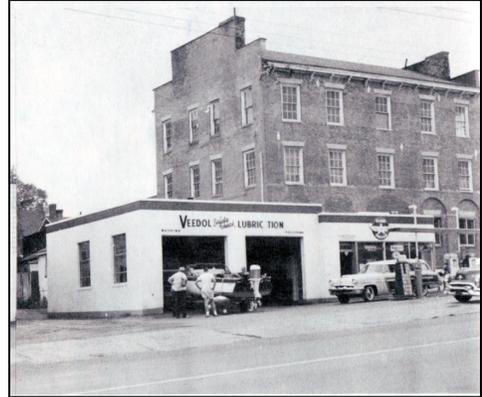
**In 1957, before the Village's preservation ordinance was adopted, a gas station was constructed disfiguring the main facade of the Phoenix Building.**

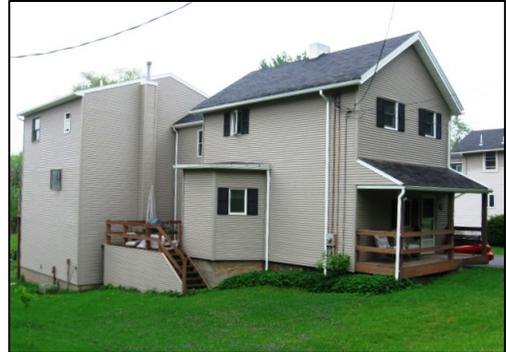
**This house in a neighboring village has lost its historic character due to poorly designed additions and alterations.**

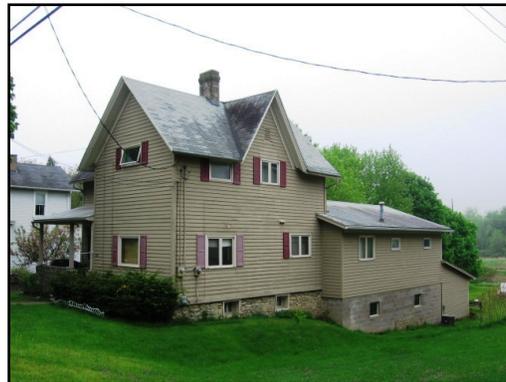
**Changing historic features such as the windows can harm the character of the building and neighborhood.**

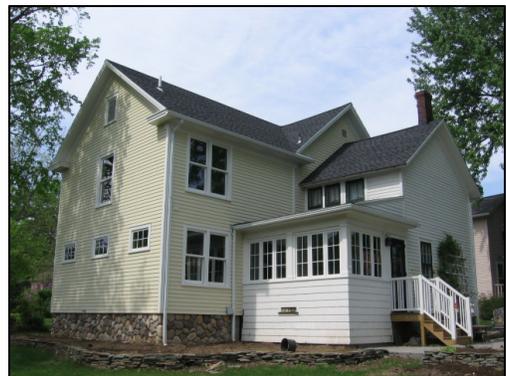
**Carefully designed changes to this Village of Pittsford house do not compromise the character of the building or neighborhood.**

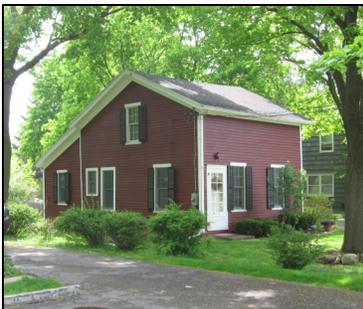
**Most of the earliest homes constructed in the village were small, 1-1/2-story, simple structures like the South Street house pictured here. Although many of these homes have survived, most have been expanded. In many village homes, the original building is the rear wing.**

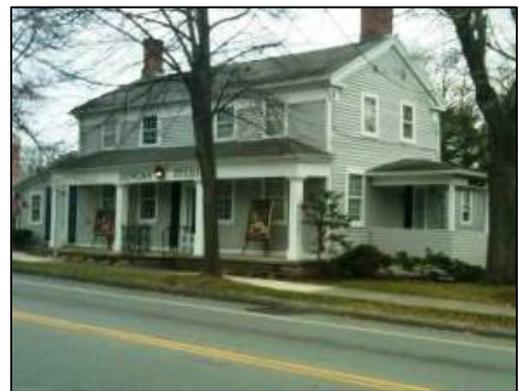
Israel Stone's house was remodeled in the Greek Revival style about 1840.

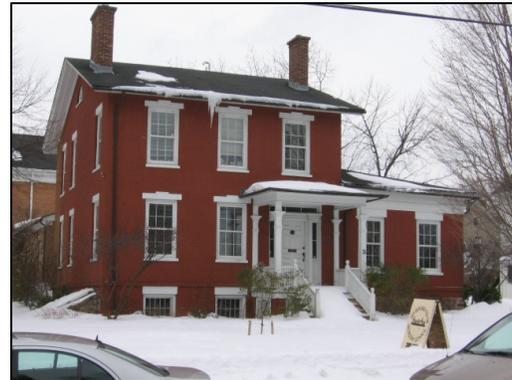
**This Federal house has a ca. 1845 Greek Revival side wing and an Italianate porch and extended eaves dating from about 1870.**

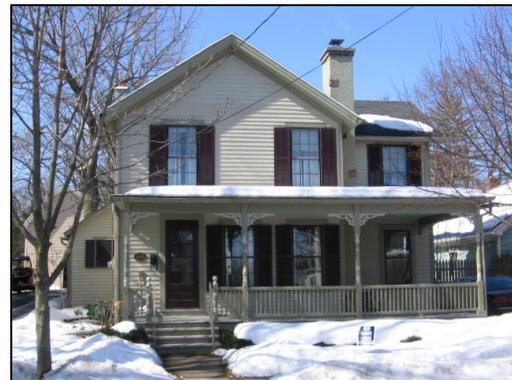
**The porch on this ca. 1860 gable-and-wing vernacular house was added in 1887 when the entire house was moved.**

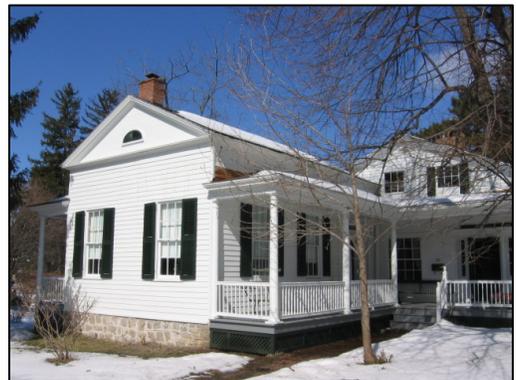
Figure 1Ca.1815 Potter-Steele House with ca. 1835 ballroom wing and porches

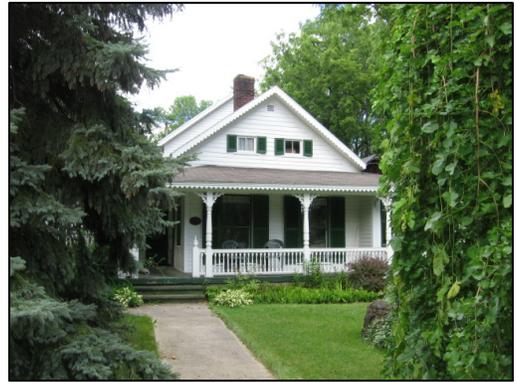
Ca. 1860 Reeves House exhibits later form of style with machine-produced ornament

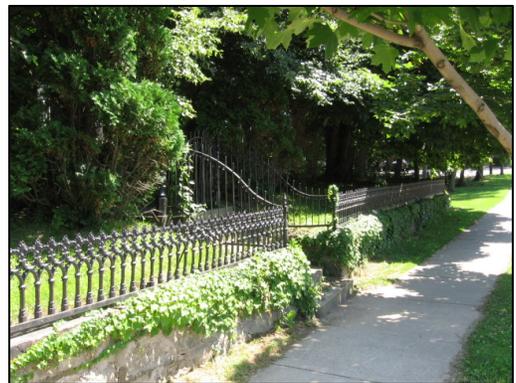
Gothic Revival cast iron fence at Pittsford Farms

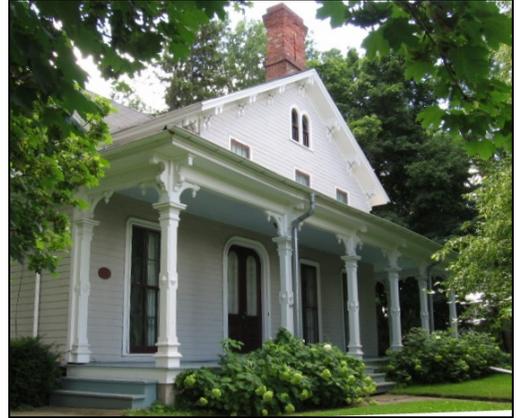
The Hildreth-Lord-Hawley-Zornow house was built in 1814 but remodeled to its present appearance in 1868.

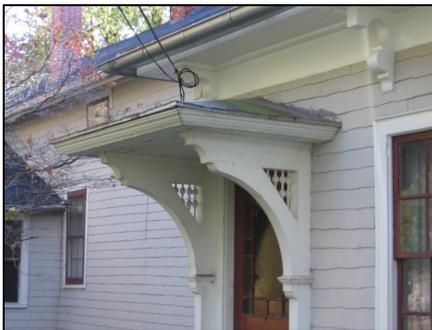
**Italianate bracketed canopy**

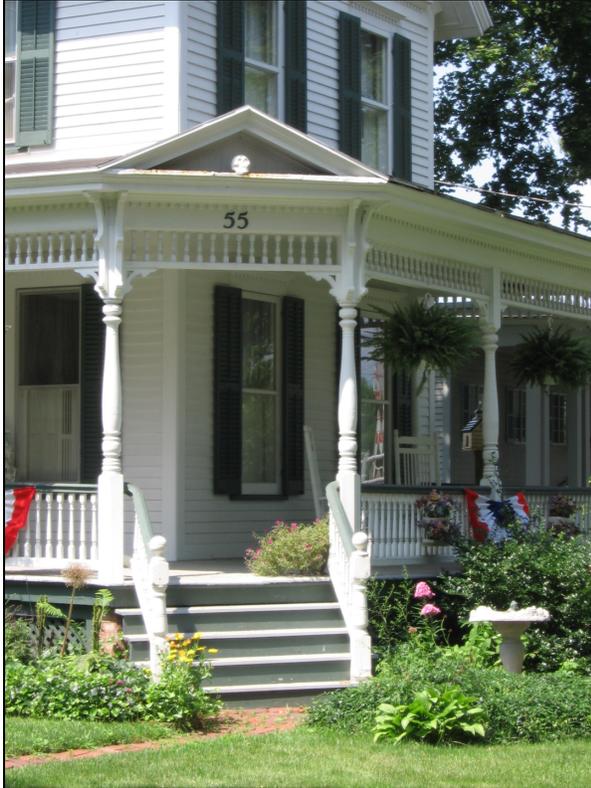
Detail of Sutherland-Richbein house showing denticulate moldings, spindle frieze, brackets and pedimented porch entrance.

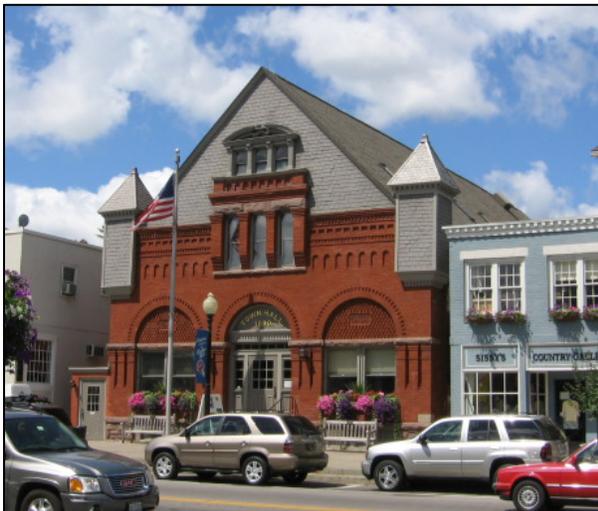
Ca. 1890 Town Hall features slate cladding in the gable and on the turrets, Medina sandstone trim, and highly ornamental brick work.

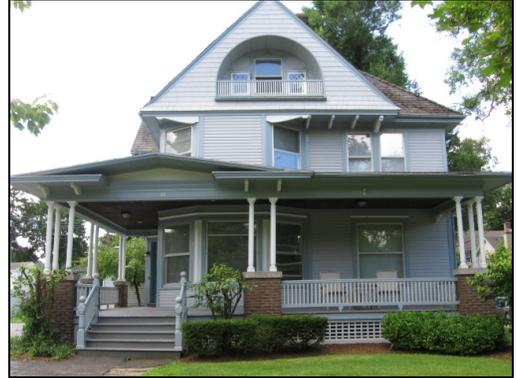
Ca. 1900 Killip/Davis House features shingle cladding and a recessed half-round barrel vault at the gable

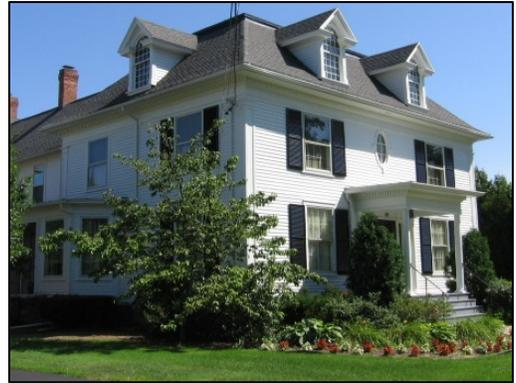
1905 Hawley house, with its formal symmetrical design, is an early example of the Georgian Revival variation of the Colonial Revival style.

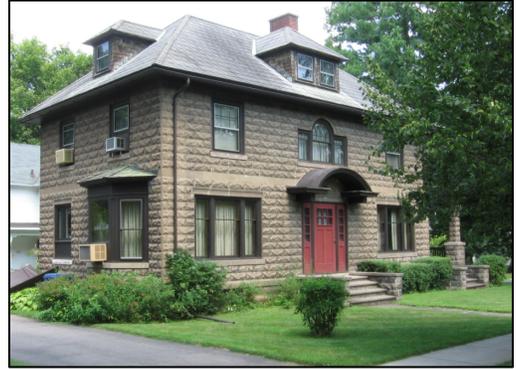
This ca. 1905 Colonial Revival home is one of a group of village buildings constructed of rock-face, site manufactured concrete block.

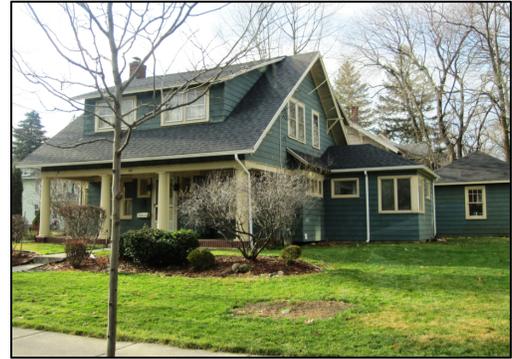
Ca 1915 Craftsman house with main gable roof extended to cover porch. Note massive Tuscan porch columns.

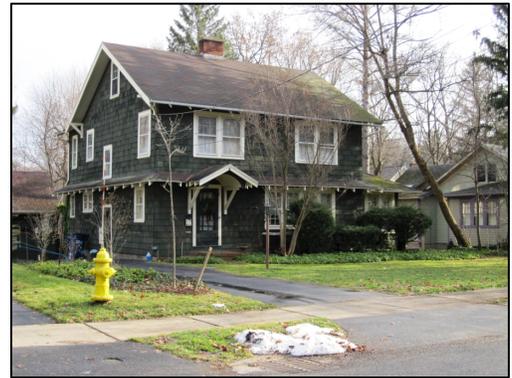
Ca. 1920 Craftsman house featuring exposed rafter tails, stained wood shingle cladding, and knee brace supports

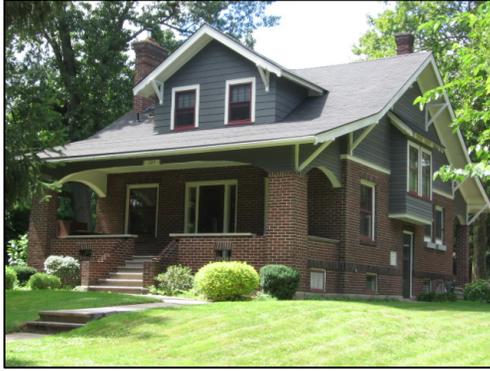
**Ca. 1910 brick Bungalow with massive brick piers supporting the porch**

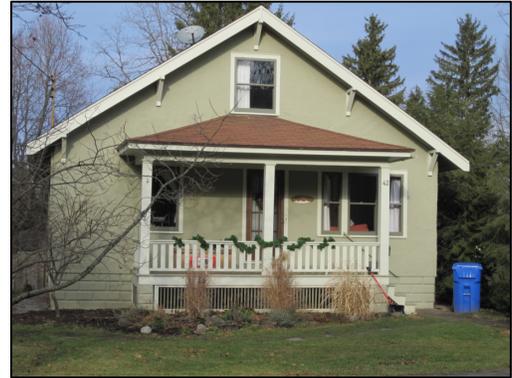
**Ca. 1925 stucco front-gable Bungalow**

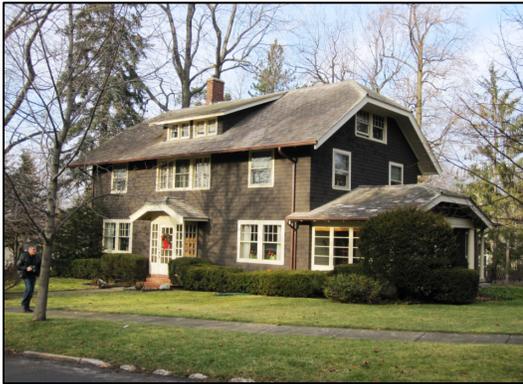
**Ca. 1915 jerkin head Craftsman house**

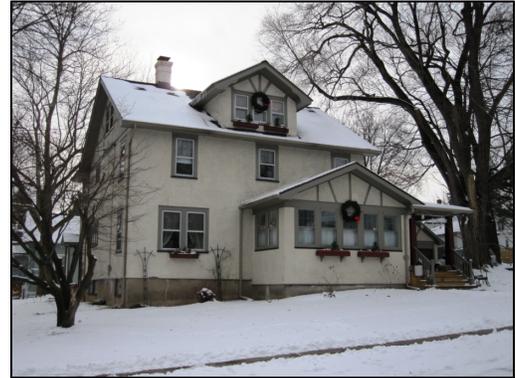
**This ca. 1920 side-gable stucco Craftsman House is the result of a remodeling of a mid nineteenth-century cobblestone structure.**

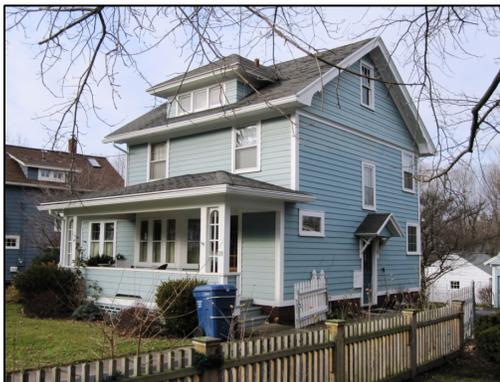
**Ca. 1927 Foursquare with Craftsman detailing**

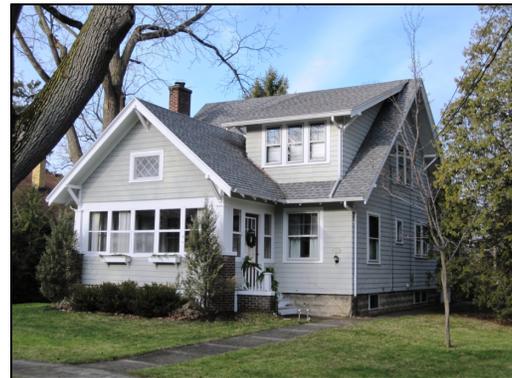
**Ca. 1925 side-gable Bungalow**

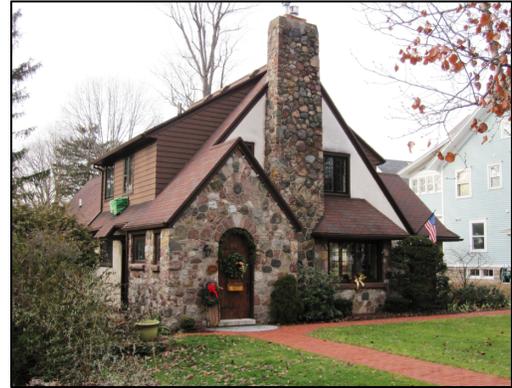
Ca. 1935 stone/stucco Tudor Revival house

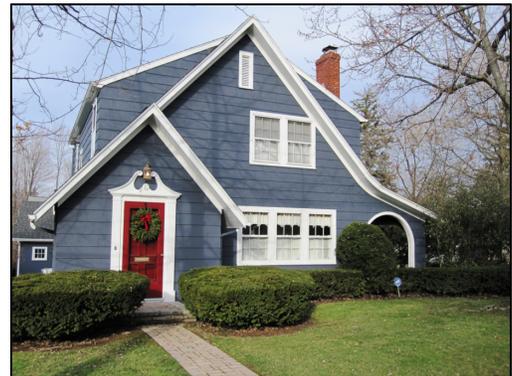
Ca. 1927 Tudor revival similar to house above but with wood shingle cladding

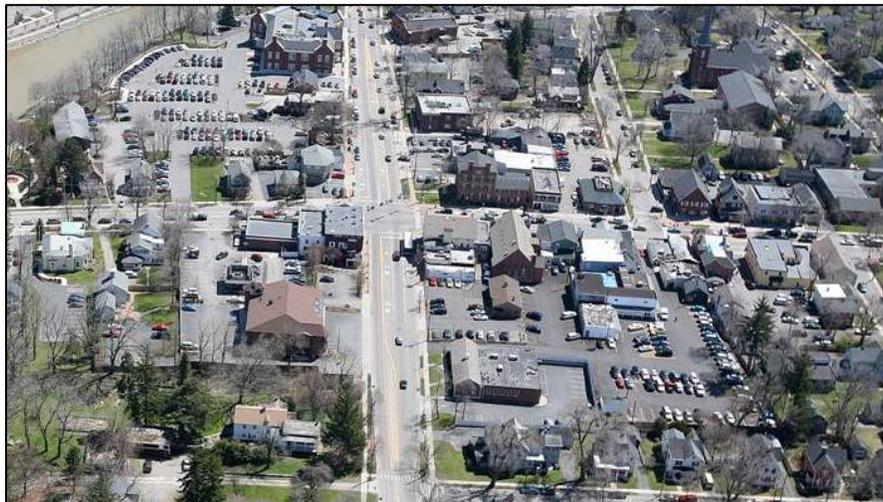
As this aerial view shows, buildings in the village are oriented with their main facade facing the street.

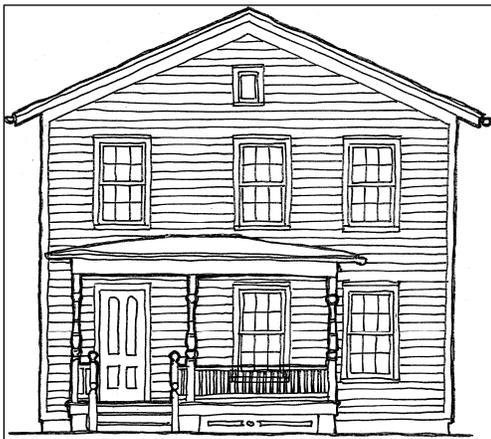
**Compatible:**  
Maintain and preserve existing façade elements, including trim, window rhythm, details, and architectural features.

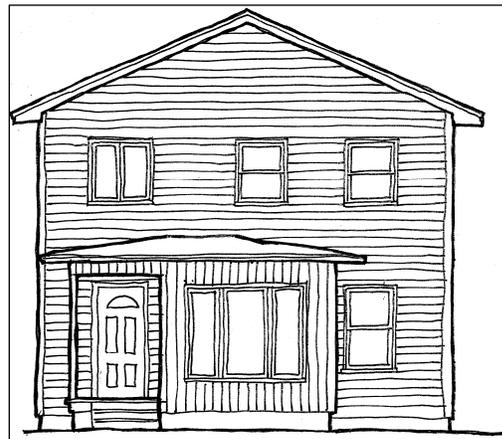
**Incompatible:**  
Altering window size, location, or style  
Enclosing an open porch  
Removing architectural details

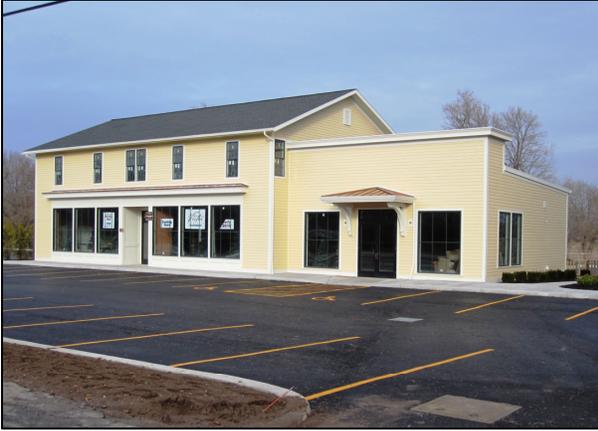
A former non-historic gas station was redesigned and enlarged in a simple style compatible with the neighboring utilitarian mills and barns in the Schoen Place waterfront district.

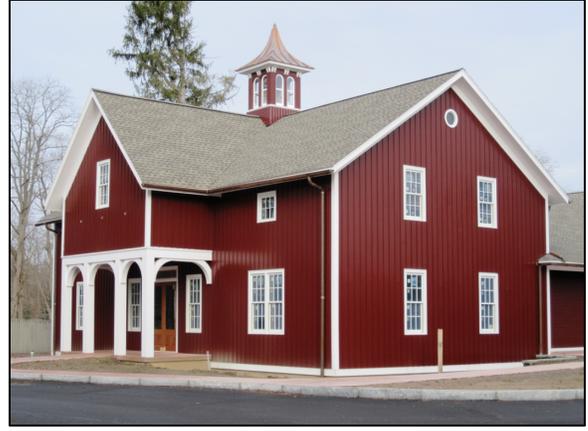
This dairy store and plant was designed to harmonize with the National Register listed farm on which it is located. The building's form, massing, roof slope, window style, and cupola relate to other structures on the property. The dairy's massing visually conceals the size of the modern plant and ensures the dairy does not visually compete with the historic main house. The building location was carefully selected to preserve historic views and landscape features and to conceal loading docks and other service elements.

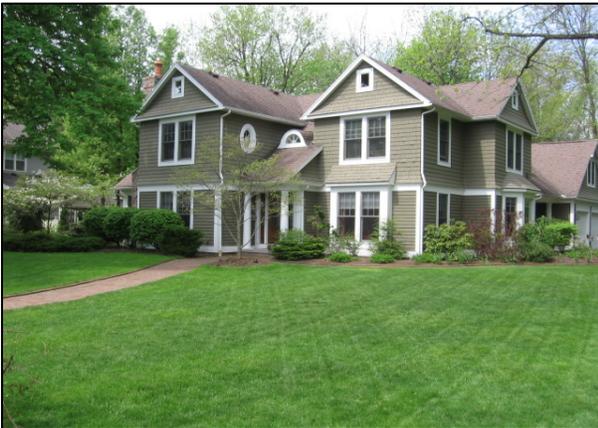
This large house employs setbacks, materials, and window proportions similar to neighboring older homes. The garage is discreetly tucked behind the house.

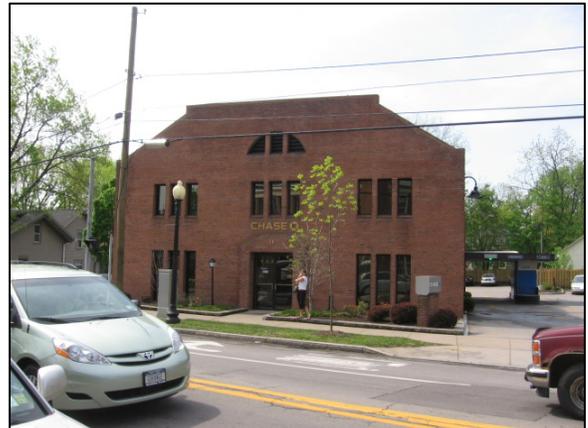
This bank shows how contemporary design can be blended with thoughtful consideration of scale, orientation, proportions and materials to produce a compatible building.

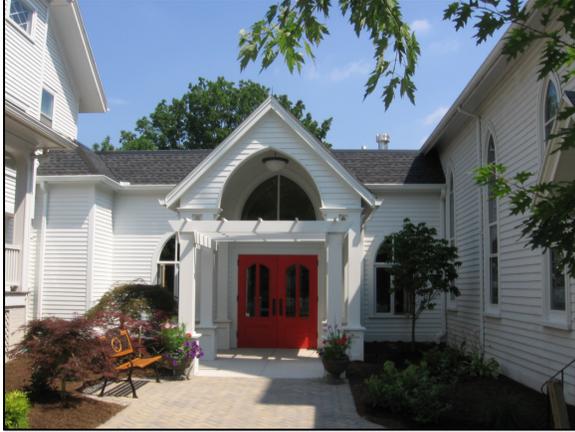
The new fellowship hall of Saint Paul's Lutheran Church matches materials and reinterprets architectural motifs found on the existing building.

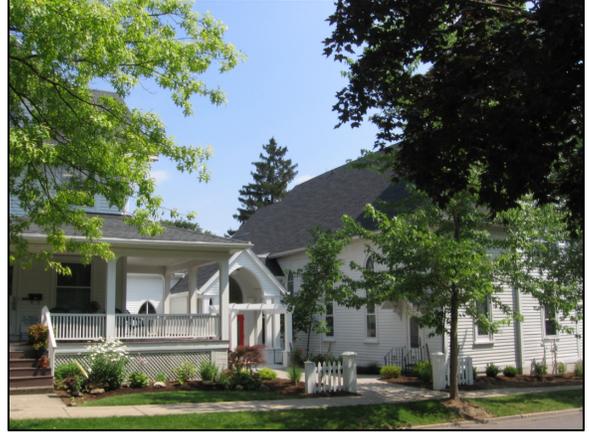
The Saint Paul's addition is set back from the two historic buildings it connects so it does not interrupt the rhythm of the street.

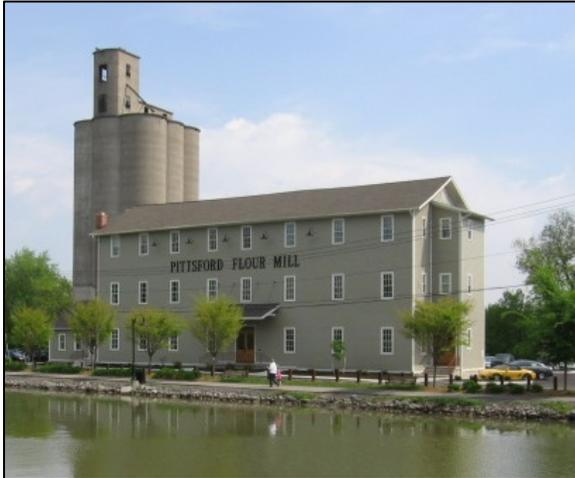
The small addition at the east end of the Pittsford Flour Mill houses mechanical equipment and a new entrance. The addition does not obscure any significant architectural features and is consistent with design of the historic building. It is small in relation to the original building. The entrance canopy is the reconstruction of a historic canopy whose appearance was documented by historic photographs.

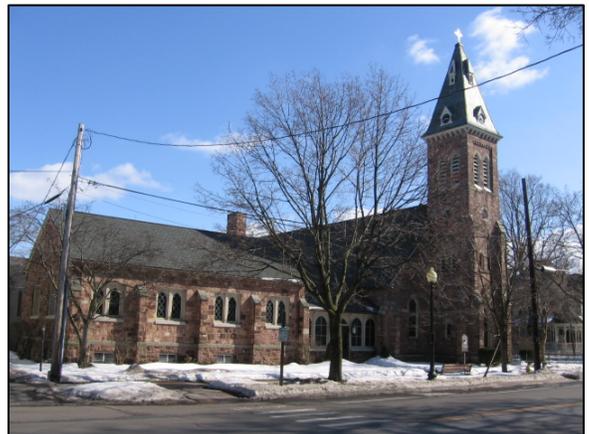
The wing was added to this Gothic Revival church over 100 years after the original building was built. By matching the exterior material (Medina sandstone) and architectural features, the wing harmonizes with the historic church. An articulated connection with lowered roof distinguishes the addition from the original building.

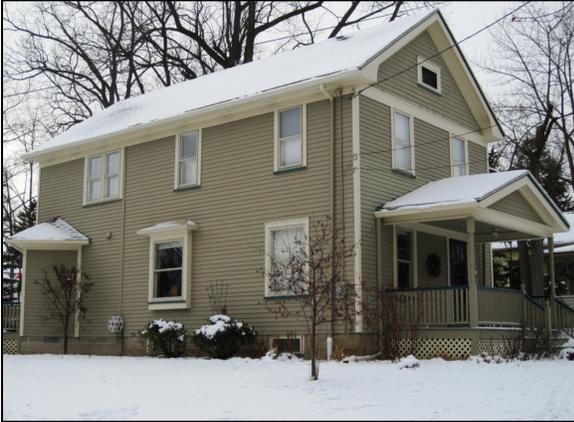
**This Foursquare home has been enlarged with a compatible rear wing. A trim board identifies the limit of the original house.**

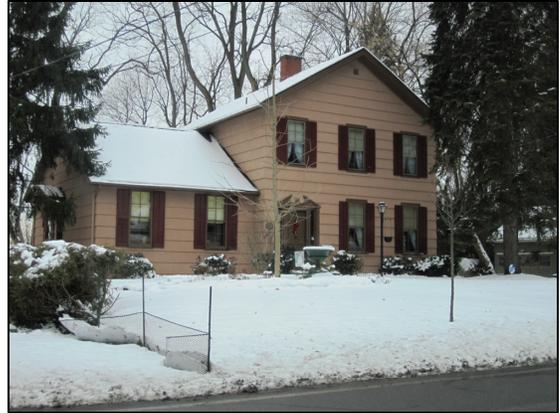
**This mid nineteenth-century home has a new side wing. The wing matches the window size and other details of the original house. The main block with side wing massing is typical of mid nineteenth-century vernacular homes.**

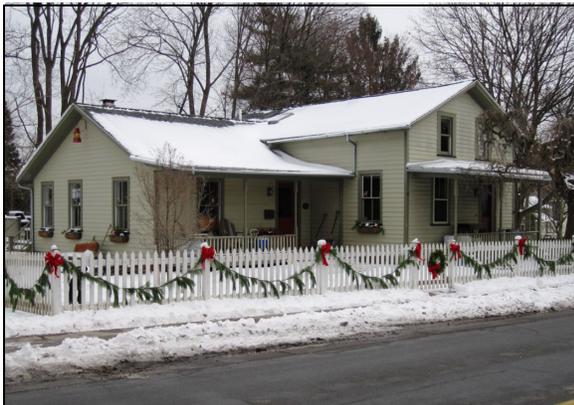
**The wing added to this early nineteenth-century home matches the window design and spacing, porch details, and roof form of the original house.**

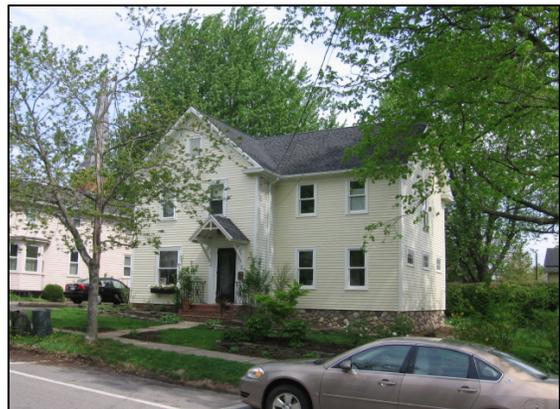
**This ca. 1910 Four-square house was enlarged with a side wing. The wing respects the simple design, roof slope, window style, void-to-solid-ratation and proportions of the original house.**

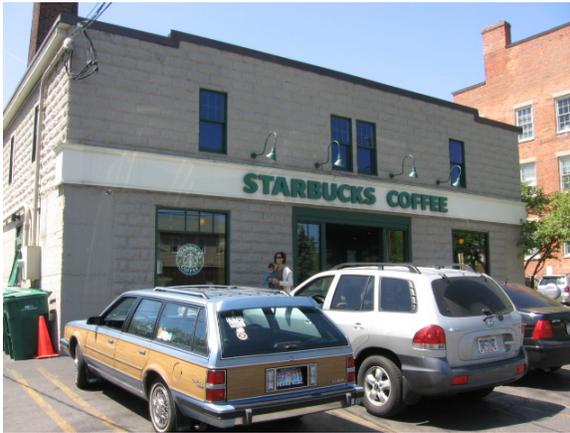
**This ca. 1915 former garage was altered to accommodate a retail use. The original materials, including site-formed rock-face concrete block, were preserved. New elements, including the sign cornice and new windows, are visually compatible with the scale and period of the building.**

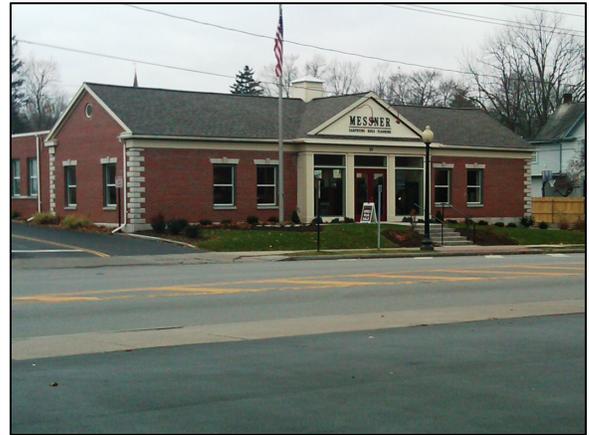
**This ca. 1960 former post office was altered to provide a storefront for the current retail occupant. The design of the new entrance is in scale with the original building and uses elements that relate to the Postwar Colonial Revival style of the original building.**

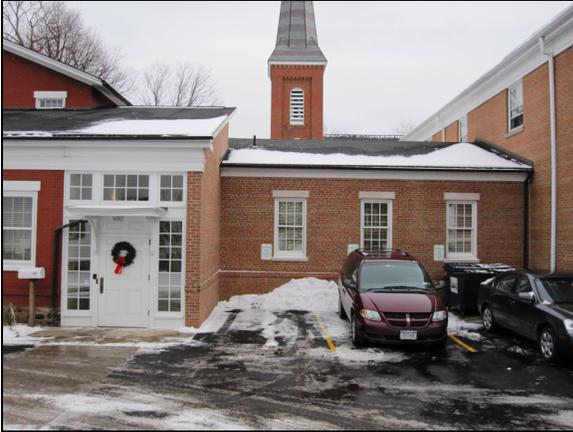
**This handicapped accessible entrance provides access to the Guetersloh House (now church offices) and the Fellowship Hall of First Presbyterian Church. The entrance matches the scale of the house and is located at the rear of the building where it is not a visually prominent feature**

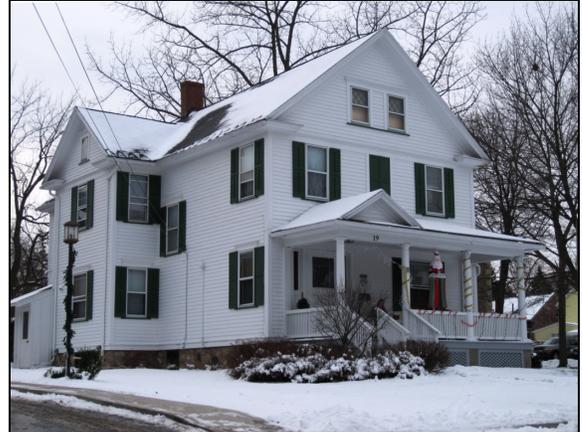
**Blown-in insulation installed in this house caused catastrophic paint failure and deterioration of the exterior clapboard. After the owner investigated remedies with a preservation architect and failed to solve the problem, the owner applied to replace the original wood clapboard with cement fiber clapboard. The application was approved because the owner provided ample documentation investigating other unsuitable solutions and because the proposed material looked visually very similar to the material being replaced.**

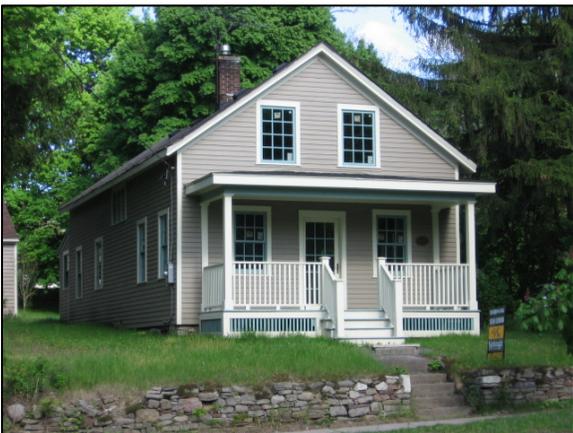
**In remodeling this small home, the owner added a new porch and requested to install casement, rather than double-hung, second-floor windows to meet current NYS Building Code egress requirements. Because the new windows carefully match the proportions and muntin pattern of the windows in the rest of the house, the application was approved.**

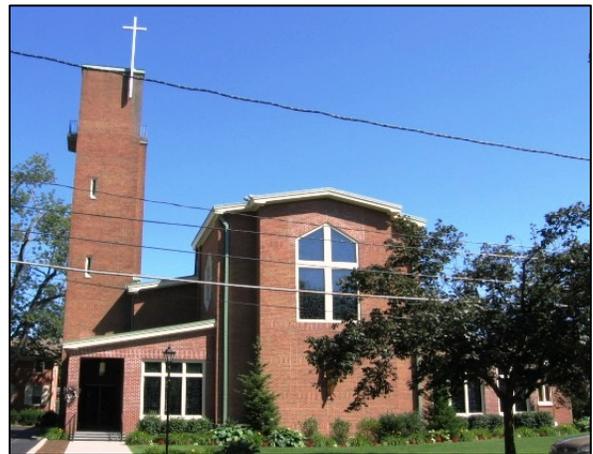
**To address liturgical changes and provide more seating, Saint Louis Church remodeled the Main Street facade of the building. The church worked with the APRB to develop a solution that would not encroach into the viewshed of adjacent historic buildings and that respected the distinguished modern period design of the church.**

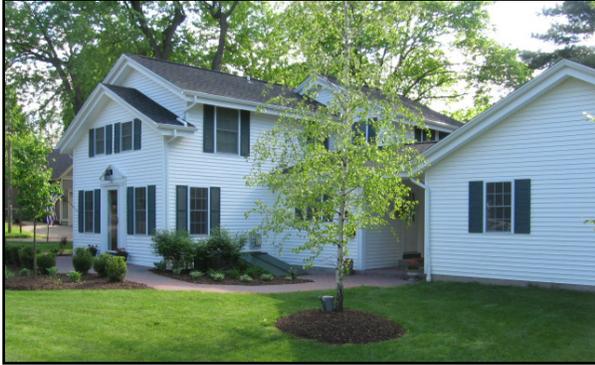
Additions have changed the scale and massing of this early nineteenth-century house. Replacement cladding and windows have made the exterior look flat and have eliminated historic trim details.

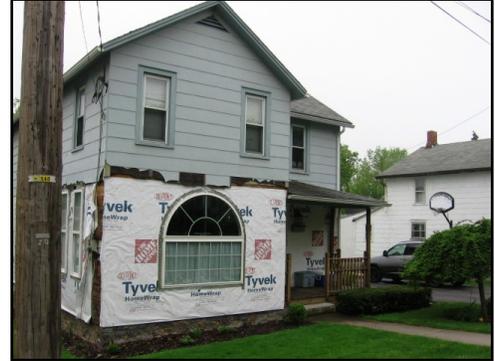
The new window added to this house is inappropriate in size, shape, proportion, and materials. Replacement porch components do not match the appearance of the original materials or design.

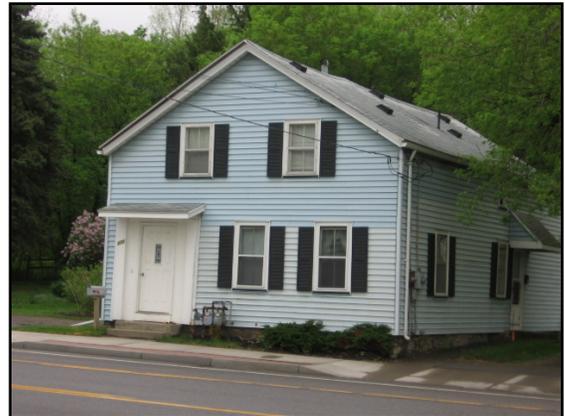
This early nineteenth-century Federal house has been stripped of its visual character by the installation vinyl siding, removal of the cornice returns, replacement of the original entrance and improperly mounted shutters. Compare the appearance of this house to the similar village of Pittsford house shown at the top of page 13.

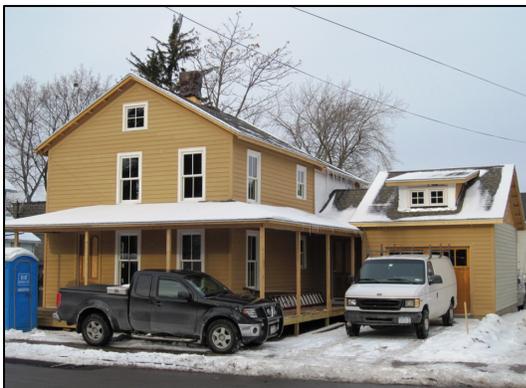
**This home is one of the few village buildings the APRB has approved to relocate. The house was located on the village's smallest lot and severely deteriorated. The building had been previously moved and was set on an inadequate foundation that was accelerating the building's decay. By moving the building forward slightly on the same property, the owner was able to build a new foundation, add a garage at the rear, and expand the house with a small addition. The changes improved the house and the neighborhood.**

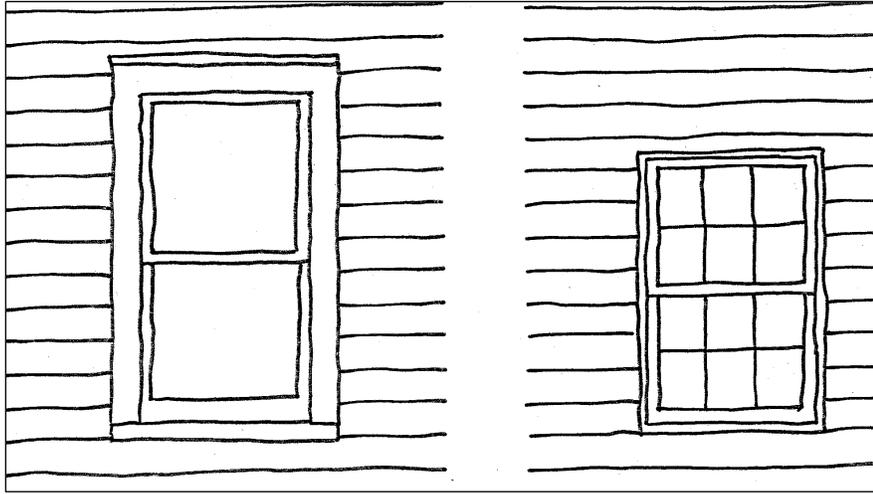
### Window openings in wood frame buildings

Windows in historic wood frame buildings are usually twice as tall as they are wide. Traditional exterior trim includes the sill, a four-inch wide casing at the sides (jamb) and at the top (head), and a wood drip mold to shed water.

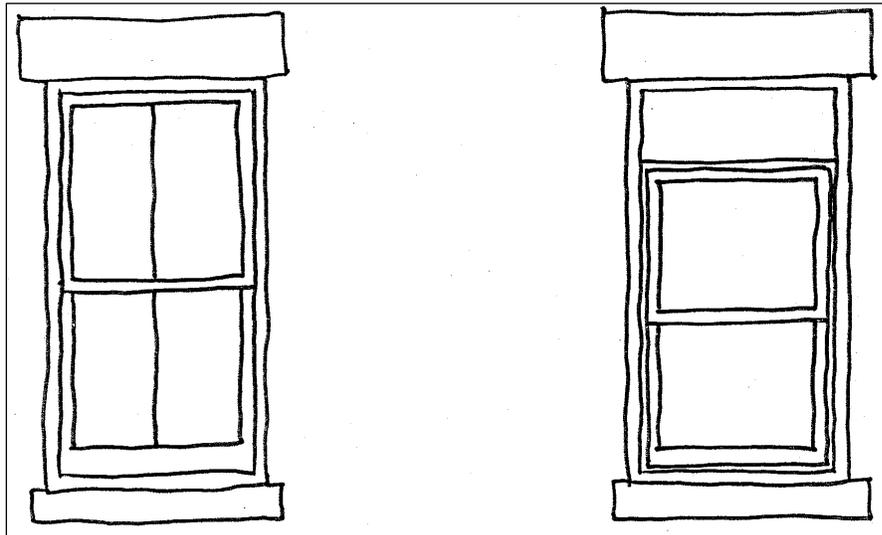
Windows in masonry buildings have a stone or concrete sill and a lintel spanning the top of the opening. The junction between the wood window frame and masonry is covered by a narrow molding called a brick mold.

Replacement windows should be the same size as the original windows and should fill the whole height and width of the masonry opening.

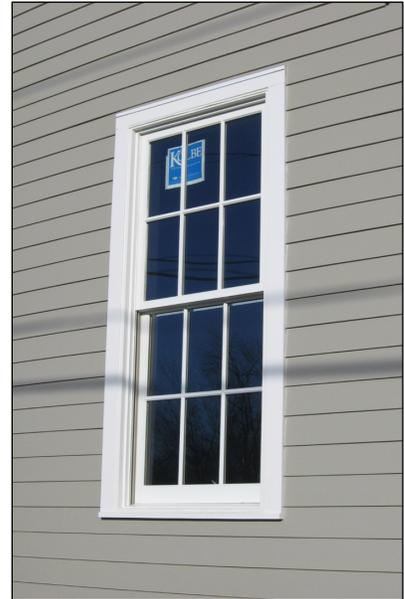
**Appropriate replacement window with simulated divided lights and profile matching the window it replaced.**

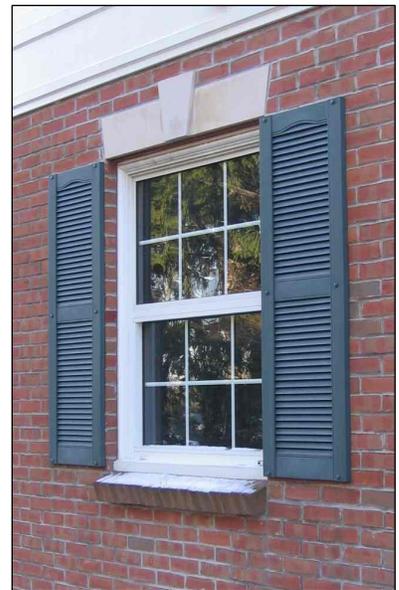
**Inappropriate replacement window: Window profiles are too wide. Grids are located on inside of glass and do not resemble muntins. Shutters do not fit opening and lack hinges.**

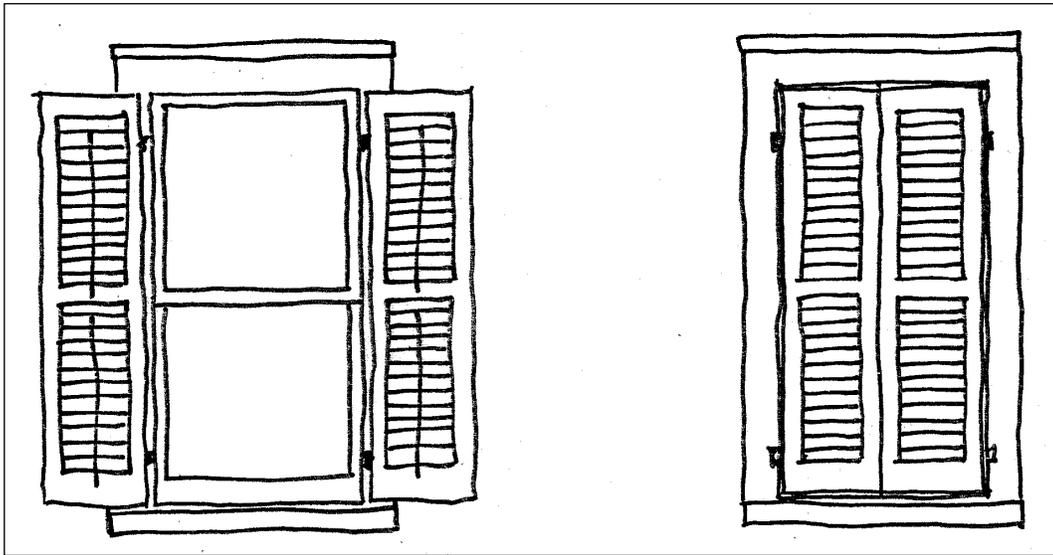
Shutters should fit the window opening and be mounted with locking hinges over the window casing. The hinges lock the shutter in either the open or closed positions. Most historic shutters had operable louvers that were anchored to a vertical wood rod. When in the closed position, shutters swing into the window opening like a door.

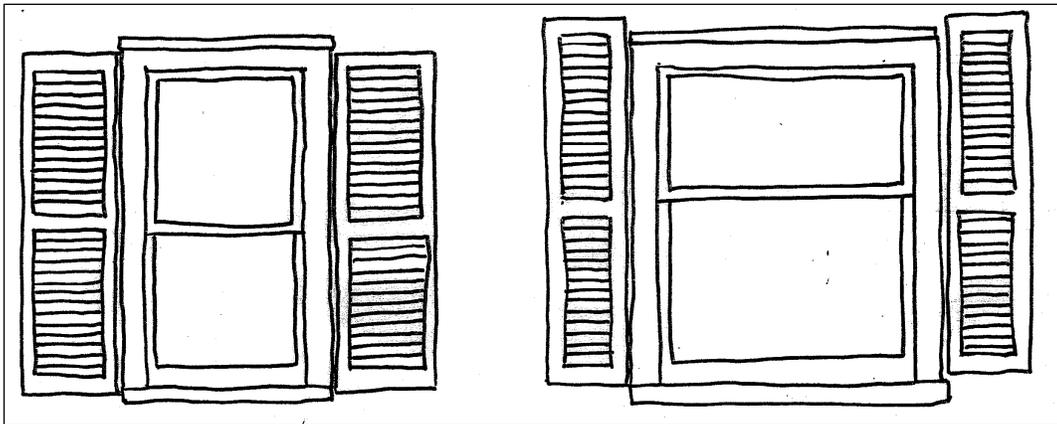
Shutters mounted flat against the siding outside of the window frame, and shutters that do not fit the size of the window opening detract from the appearance of historic buildings

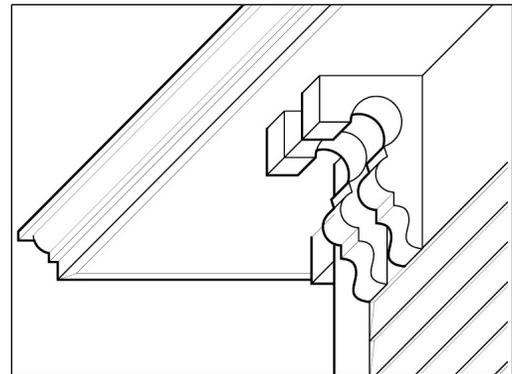
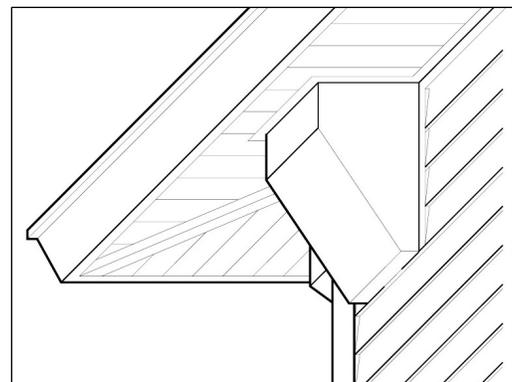
**Substitute cladding materials often destroy or conceal architectural details. The illustrations above show how the appearance of an eave and brackets is changed by the application of the aluminum panning that is a standard component of a vinyl siding installation.**

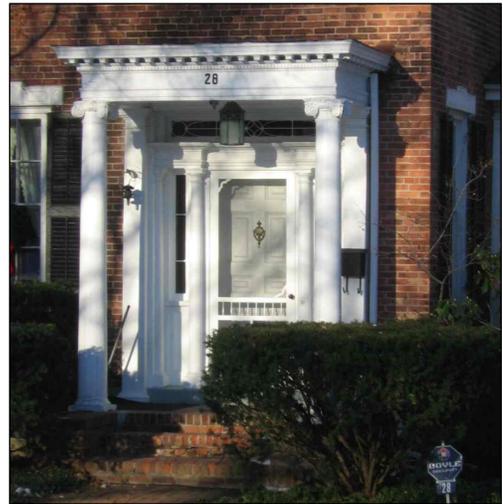
**This historic porch was carefully designed and proportioned to coordinate with classical detailing and other design elements on this historic house.**

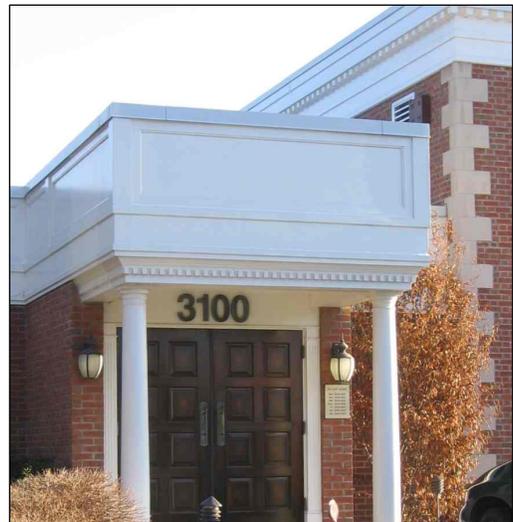
**This modern porch combines classical elements without an understanding of their proportions or inter-relationship. As a result, this porch has an awkward and inappropriate top-heavy appearance.**

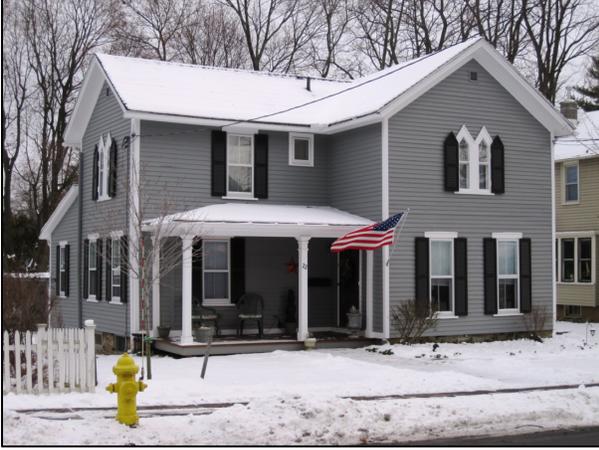
The square posts of this new porch complement the simple mid nineteenth-century lines of this gable-and-wing house.

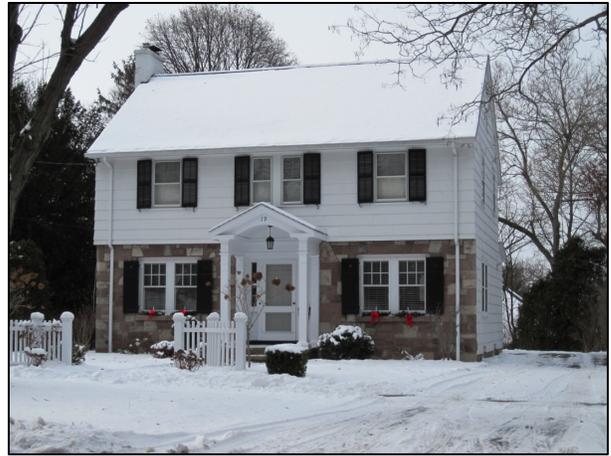
Gabled entry porch, with cornice returns and barrel-vault ceiling, suits the style of this 1940s Colonial Revival style home.

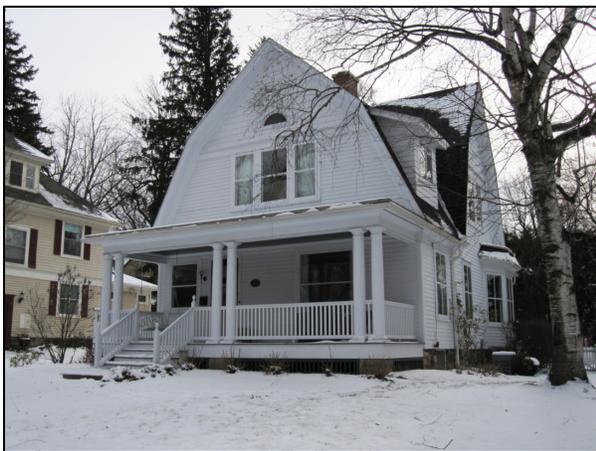
Like many village homes, this ca. 1902 Dutch Colonial had its porch removed in 1950s. Reviewing historic photographs provided design information to allow construction of a new porch that matches the design language and scale of the original.

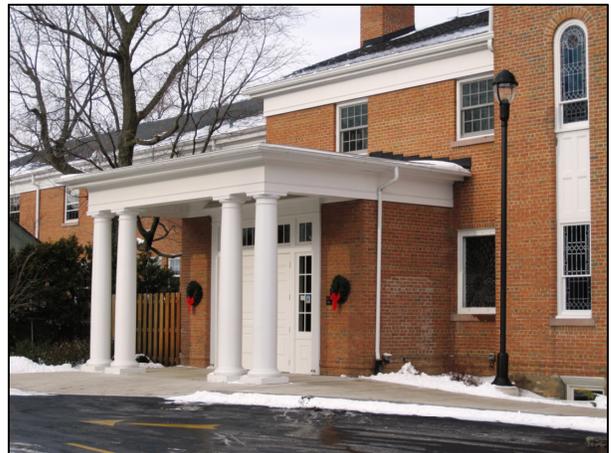
The rear entrance of First Presbyterian Church was redesigned to provide cover from the weather and accommodate handicapped persons. The style of the new entrance and porch matches the Colonial revival style of the churches ca. 1968 Fellowship Hall. The Tuscan porch columns, with proper entasis, are fiberglass. The columns were approved by the APRB because their appearance is very similar to wood

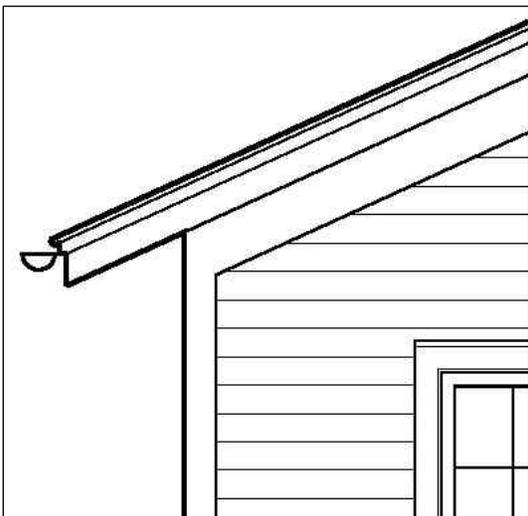
**Traditional eave detail, often called the “plumb-cut eave”;** the soffit is parallel to the roof slope and the fascia is vertical.

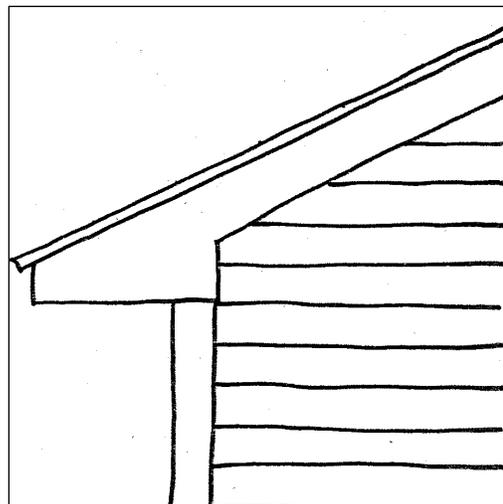
**The modern boxed soffit is not appropriate for many pre-1950 buildings.**

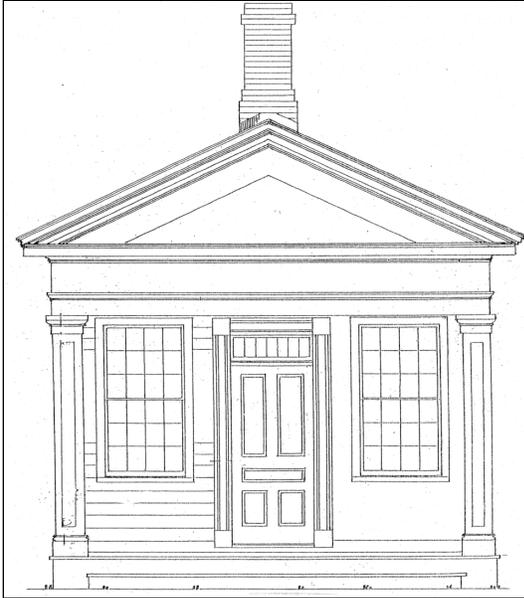
**Pediment**—Gable treatment where a triangle is formed by the two raking cornices and a continuous horizontal cornice across the base of the gable

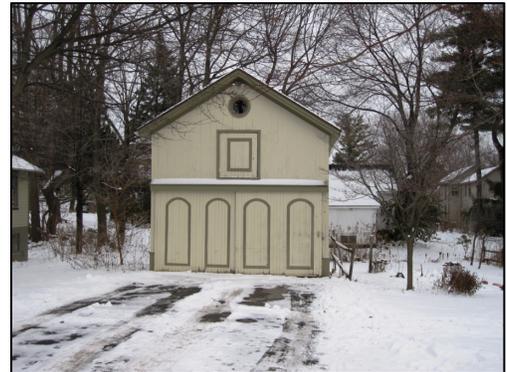
**One of the village’s many surviving nineteenth-century horse barns.**

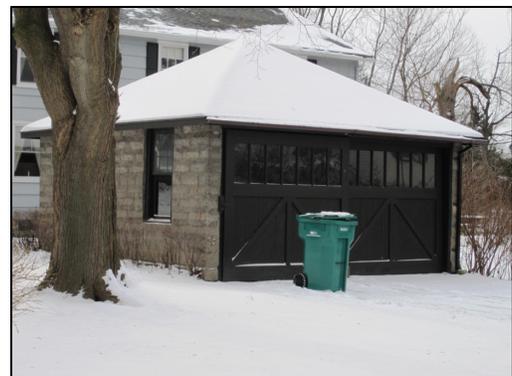
**An early twentieth-century garage retaining its original sliding doors**

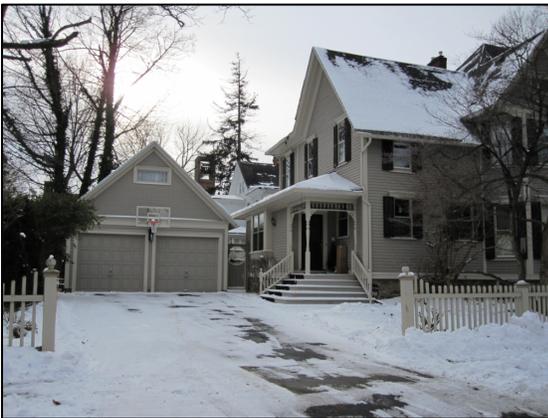
This garage incorporates a roof slope and unique gable detailing matching the adjacent Queen Anne style "Gomph" house.

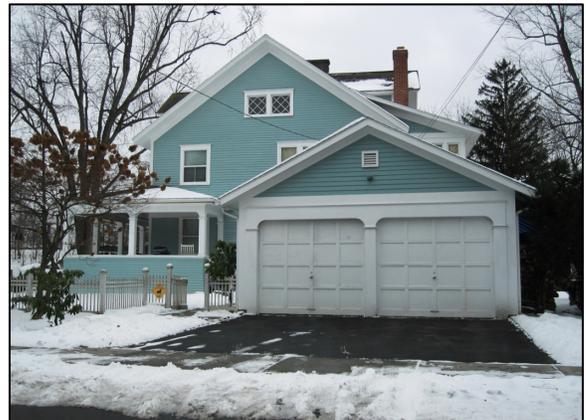
The garage of this house faces the side street. The rounded corners of the garage door openings mimic the porch column profile found on the house.

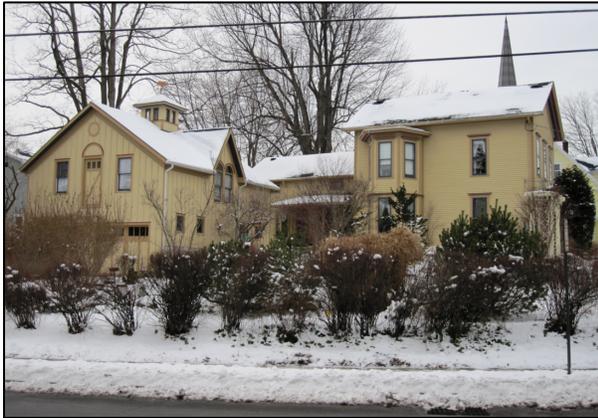
The garage next to this Italianate house was designed to recall a mid nineteenth-century carriage barn. Note the board-and batten siding, cross gable, cupola, and half-round windows.

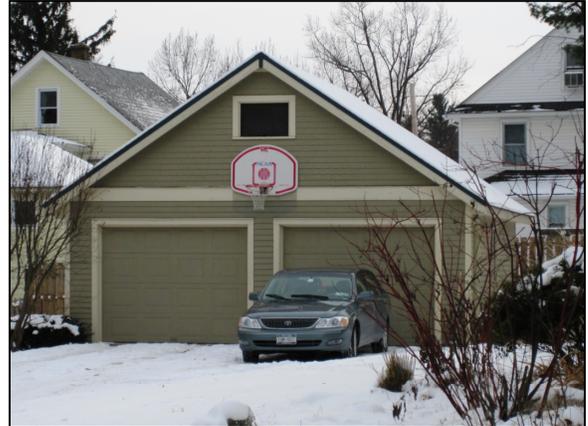
When an existing severely deteriorated single-car garage was replaced with a larger two-car structure, the form, roof slope, and trim details of the original were incorporated into the new design.

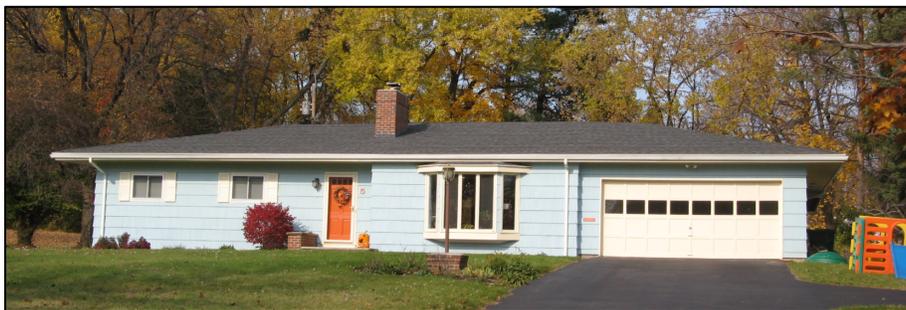
### Ranch

Ranch houses became very popular in the Post-WWII period, particularly in the 1960s and 1970s. Nationwide, this house type had its roots in the west, where long, low rooflines were reminiscent of the Prairie Style of the early twentieth century. One-story houses with deep roof overhangs, a strong horizontal emphasis, and horizontal ribbons of windows reflect this emphasis. The decorative details may vary, with many of the houses in Pittsford displaying historically inspired details, such as diamond-paned windows and shutters, while a few are distinctly contemporary in their styling. Exotic variations of the style that are common in some regions of the country are not found here. The popularity of the style reflects a desire for an informal lifestyle, one-story living space, and the increased reliance on the automobile.
