# VILLAGE OF PITTSFORD

## Historic and Architectural Design District Building Design Standards

# Village of Pittsford Historic and Architectural Design District Building Design Standards

Revision 1: January 17, 2010

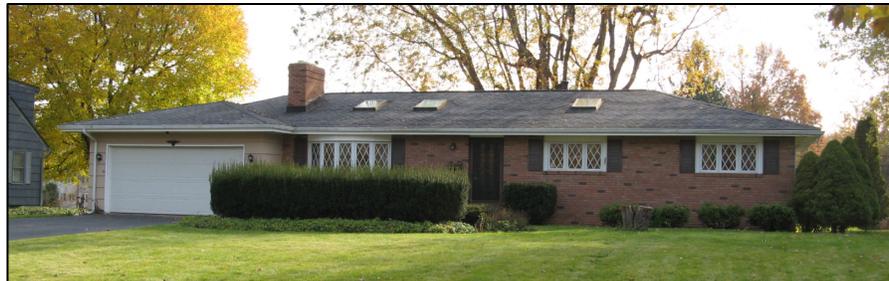
- **Windows:** Picture, bay, and casement windows are common; may be wood, steel, or aluminum frame. There may be decorative shutters. Diamond-paned windows are fairly common.

- **Door:** May be single or paired; paneled or plain.
- **Details:** Decorative details are minimal.
- **Garage:** Attached, usually with a roofline continuous with the rest of the house.

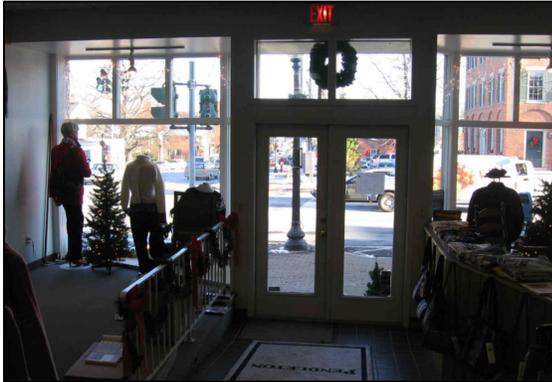
Storefronts connect interior activity with the street.

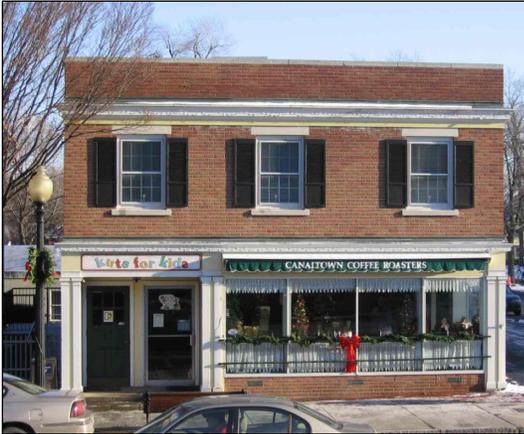
Appropriate roll-type awning installation with sign lettering located on the lower flap. Awning is in the rolled-up position.

- On both fully extended roll-up awnings and fixed awnings, the lower flap of the awning shall be at least 7'-6" above the sidewalk.
- Awnings on a house should be placed in a logical pattern, such as on all windows on a facade, or on just the windows on the first floor; they should usually not span across multiple openings. Be aware that awnings can conflict with shutters.

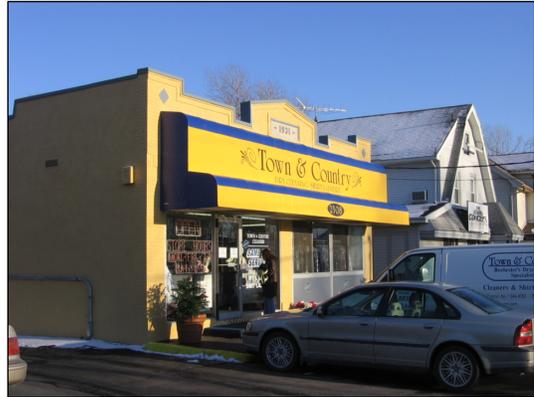
Awnings that are too large, too colorful, and/or too complicated in shape diminish the appearance of the building.

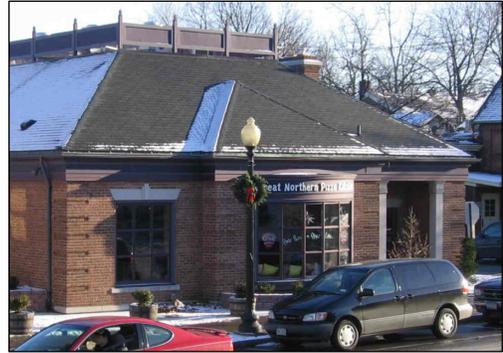
**On this building, an architecturally compatible screen was used to conceal roof top mechanical equipment.**

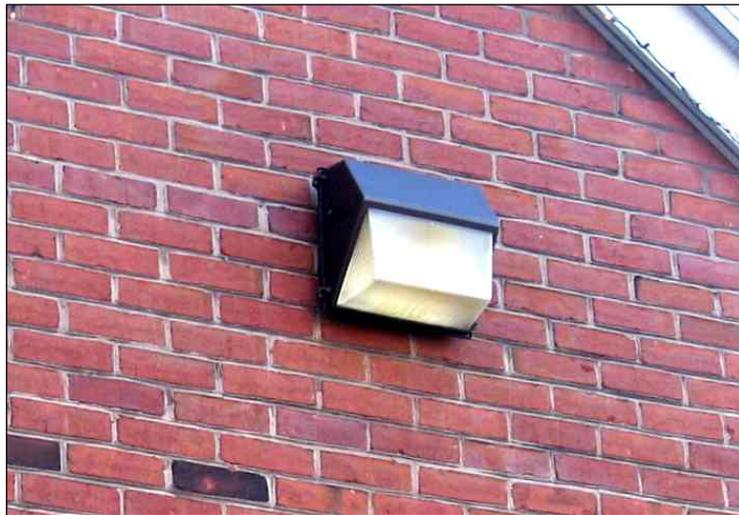
**“Wallpacks” and other common types of unshielded security lighting create intense glare and are prohibited within the Village of Pittsford.**

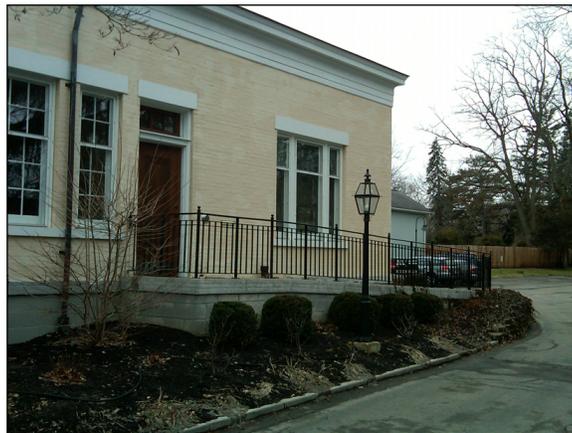
**New handicap ramp addition on the side of village hall**

- Ramps must be designed in accordance with the provisions of the Building Code of New York State and other applicable codes.
