SECTION 5

Rehabilitation Standards for Historic Buildings

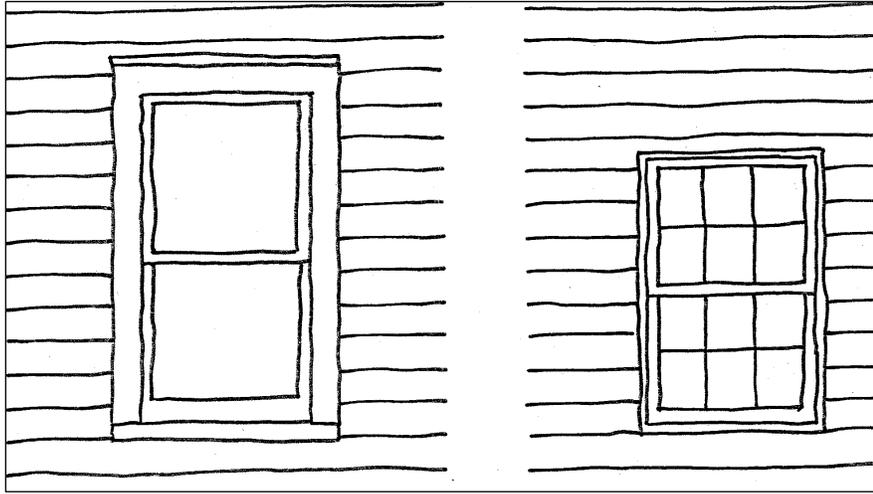
Window openings in wood frame buildings

Windows in historic wood frame buildings are usually twice as tall as they are wide. Traditional exterior trim includes the sill, a four-inch wide casing at the sides (jamb) and at the top (head), and a wood drip mold to shed water.

Stock modern windows lack traditional trim and therefore they are not visually compatible with older buildings. Contractors and architects usually will not select appropriate window sizes and shapes unless they are directed to do so.

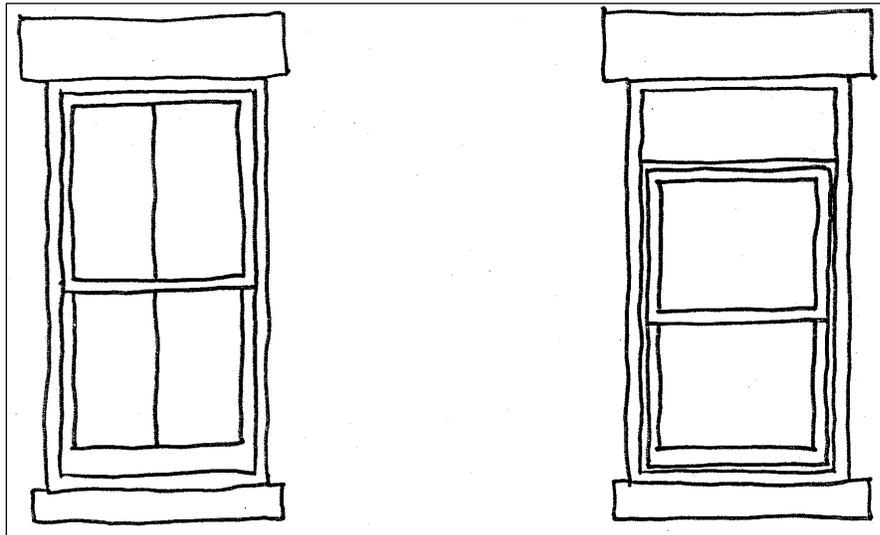
Window openings in masonry buildings

Windows in masonry buildings have a stone or concrete sill and a lintel spanning the top of the opening. The junction between the wood window frame and masonry is covered by a narrow molding called a brick mold.

Replacement windows should be the same size as the original windows and should fill the whole height and width of the masonry opening.

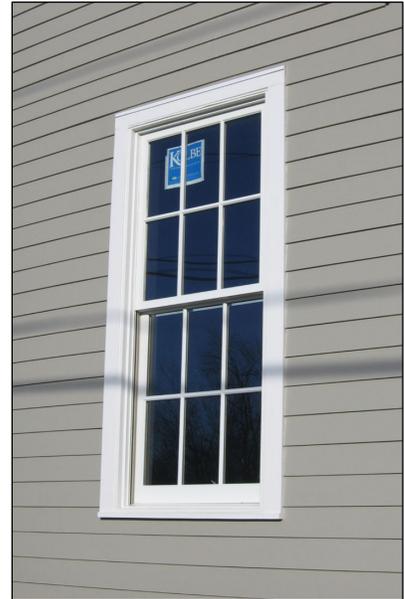
Appropriate replacement window with simulated divided lights and profile matching the window it replaced.

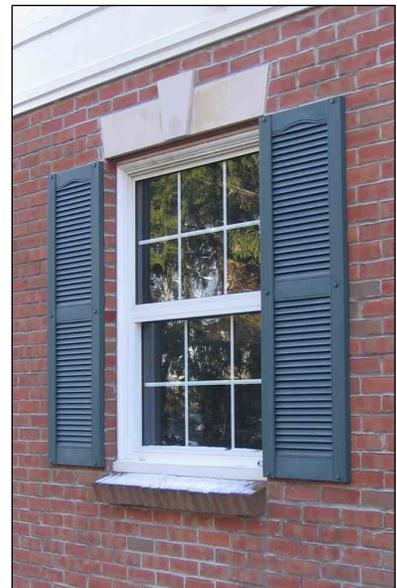
Inappropriate replacement window: Window profiles are too wide. Grids are located on inside of glass and do not resemble muntins. Shutters do not fit opening and lack hinges.

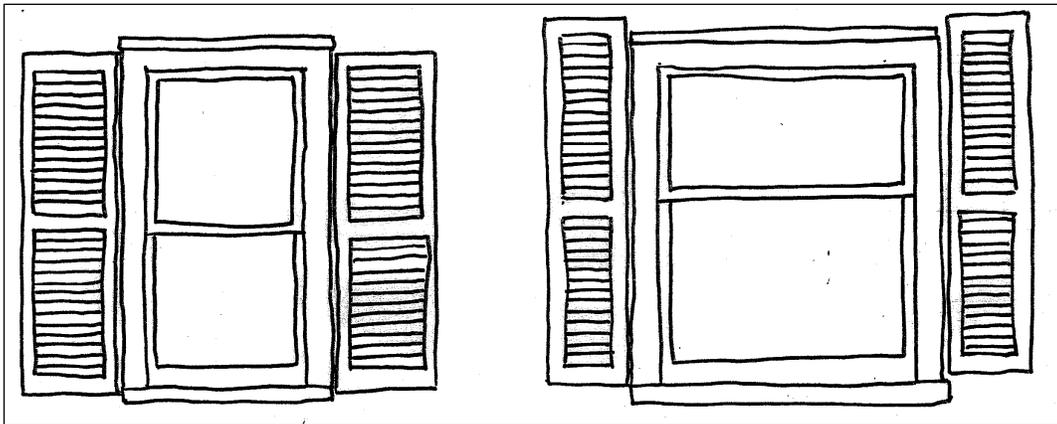
Common Mistakes with Shutters

Shutters mounted flat against the siding outside of the window frame, and shutters that do not fit the size of the window opening detract from the appearance of historic buildings

Shutters should be operable and hung on hinges. Shutters should never be fixed directly to the siding outside of the window casement trim. When shutters are mounted directly to the face of a house, there is no ventilation between the shutter and the house. The lack of air movement holds moisture against the building and accelerates deterioration of paint and siding. You can study historic photographs or pattern books or other homes in your neighborhood for ideas on shutter and hardware styles.

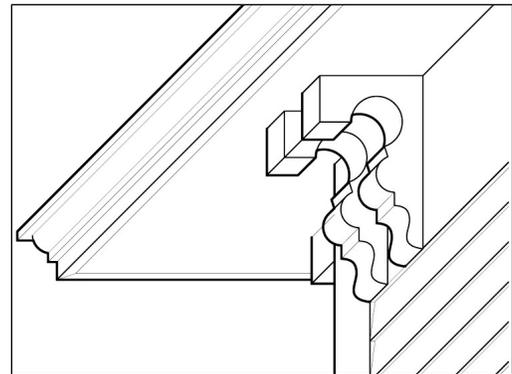
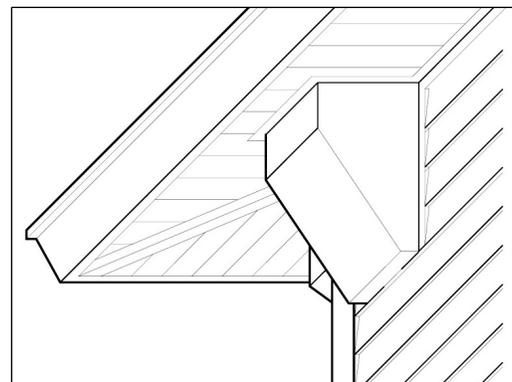
Substitute cladding materials often destroy or conceal architectural details. The illustrations above show how the appearance of an eave and brackets is changed by the application of the aluminum panning that is a standard component of a vinyl siding installation.

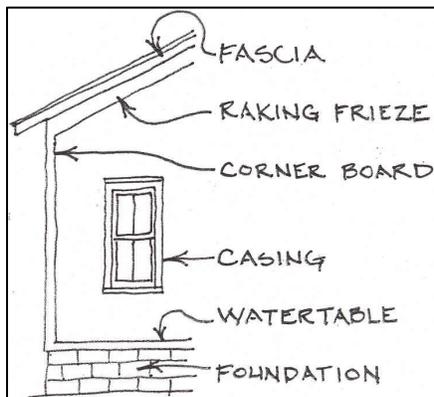
Typical wood-frame building trim

Wood-Frame Construction - In wood-frame buildings, decorative trim is provided at most junctions between different materials and between different surfaces. These include the top of the foundation (watertable), corners (corner boards), roof (frieze trim), and openings (casings). Door and window casings are typically four inches wide, while trim at the frieze, watertable, and corners is often wider.

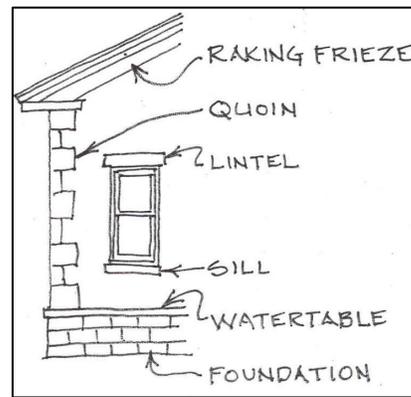
Typical masonry building trim

Masonry Construction - In traditional masonry buildings, the same junctions are highlighted, but in different ways. At the division between the foundation and the exterior wall above, the watertable is indicated by a change in materials and is occasionally accentuated by a slight horizontal projection. Corners can be emphasized by quoins or pilasters. The frieze can be either wood trim or a differentiated treatment of the unit masonry wall material. Openings are emphasized by sills, lintels, arches, and/or rowlock header courses. Masonry construction usually respects gravity, which means that there is a transition from heavier, rougher materials located near the ground to progressively lighter materials at the top of the building.

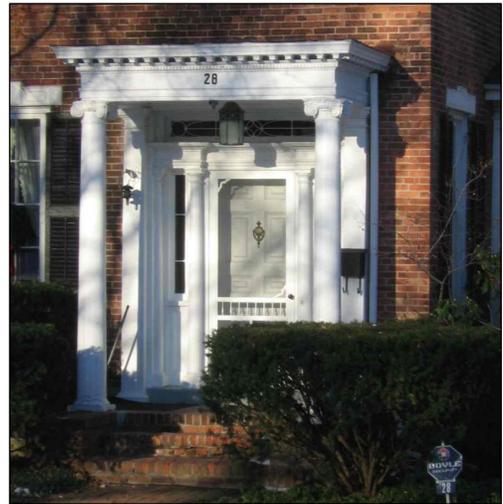
This historic porch was carefully designed and proportioned to coordinate with classical detailing and other design elements on this historic house.

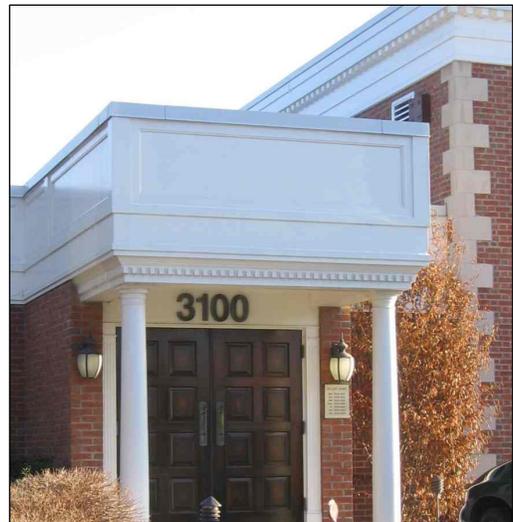
This modern porch combines classical elements without an understanding of their proportions or inter-relationship. As a result, this porch has an awkward and inappropriate top-heavy appearance.

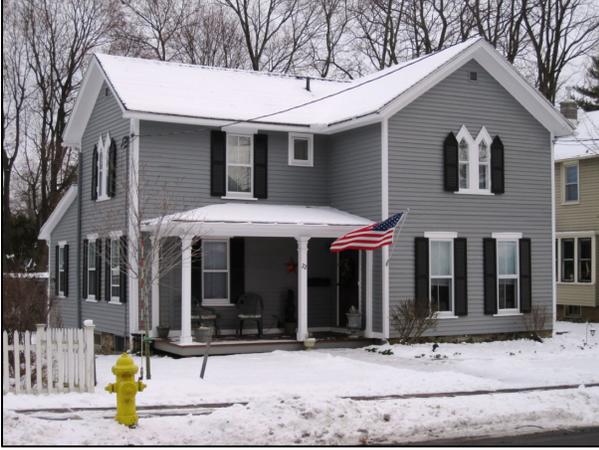
The square posts of this new porch complement the simple mid nineteenth-century lines of this gable-and-wing house.

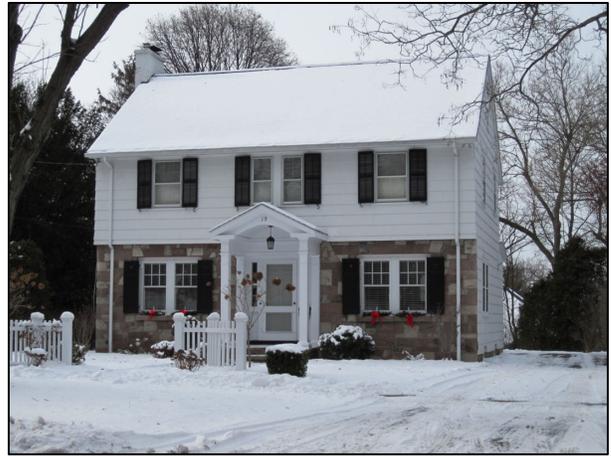
Gabled entry porch, with cornice returns and barrel-vault ceiling, suits the style of this 1940s Colonial Revival style home.

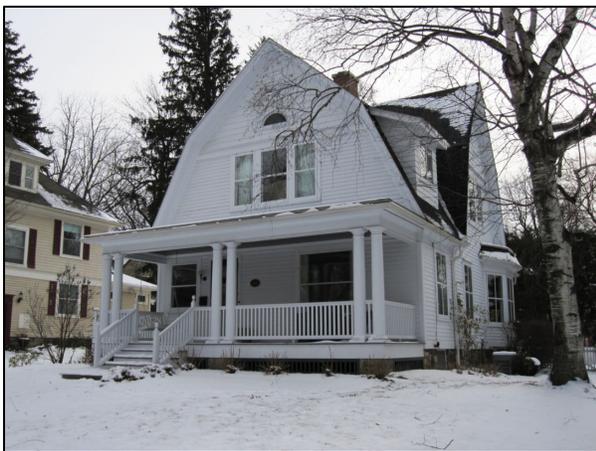
Like many village homes, this ca. 1902 Dutch Colonial had its porch removed in 1950s. Reviewing historic photographs provided design information to allow construction of a new porch that matches the design language and scale of the original.

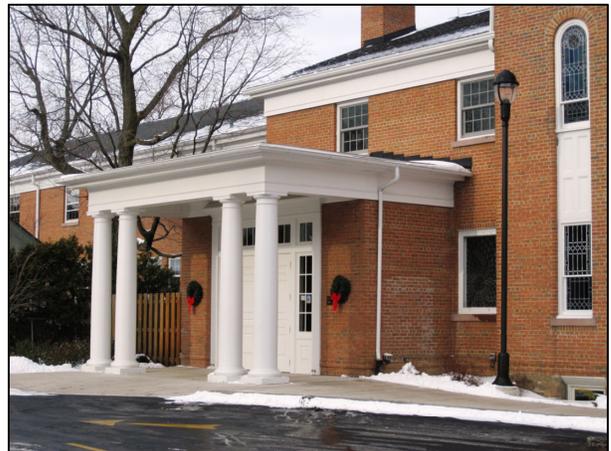
The rear entrance of First Presbyterian Church was redesigned to provide cover from the weather and accommodate handicapped persons. The style of the new entrance and porch matches the Colonial revival style of the churches ca. 1968 Fellowship Hall. The Tuscan porch columns, with proper entasis, are fiberglass. The columns were approved by the APRB because their appearance is very similar to wood

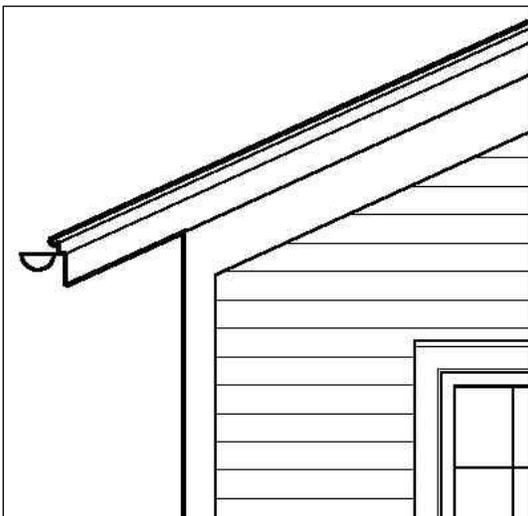
Traditional eave detail, often called the “plumb-cut eave”; the soffit is parallel to the roof slope and the fascia is vertical.

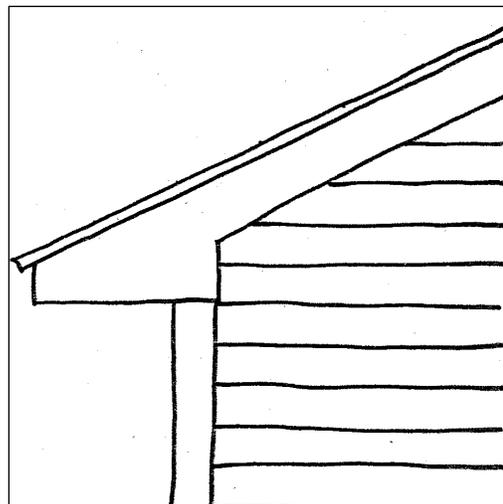
The modern boxed soffit is not appropriate for many pre-1950 buildings.

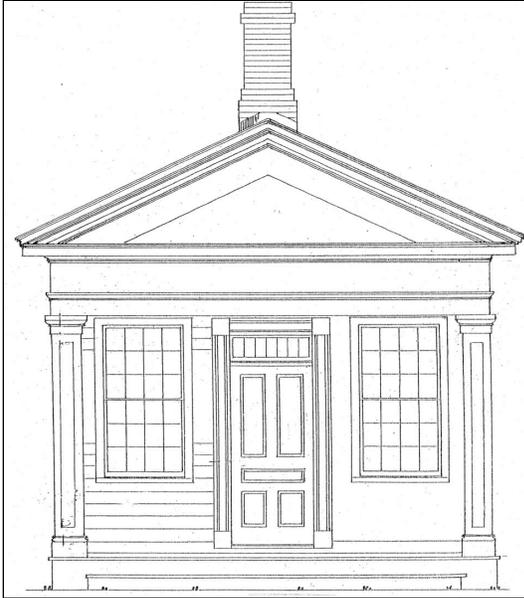
Pediment—Gable treatment where a triangle is formed by the two raking cornices and a continuous horizontal cornice across the base of the gable

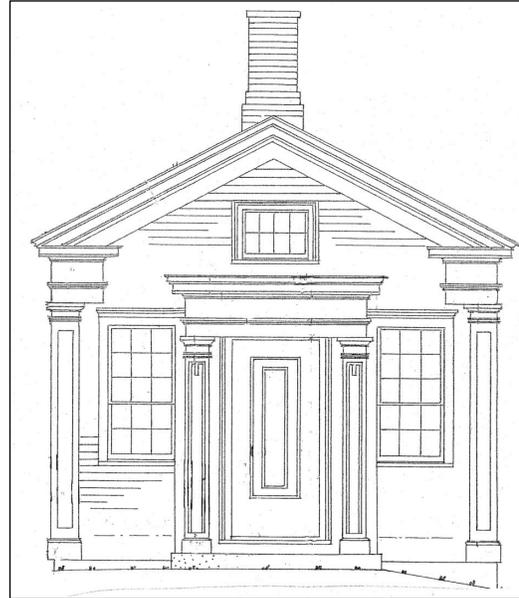
Cornice return—Similar to pediment except horizontal cornice is not continuous

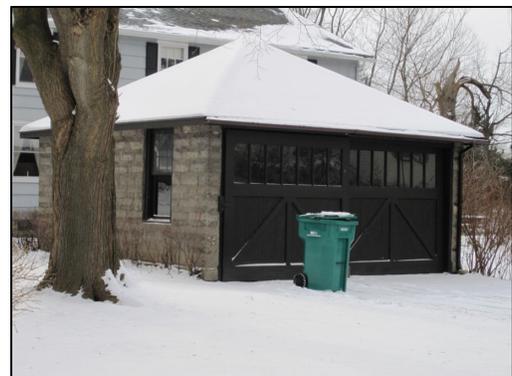
An early twentieth-century garage retaining its original sliding doors

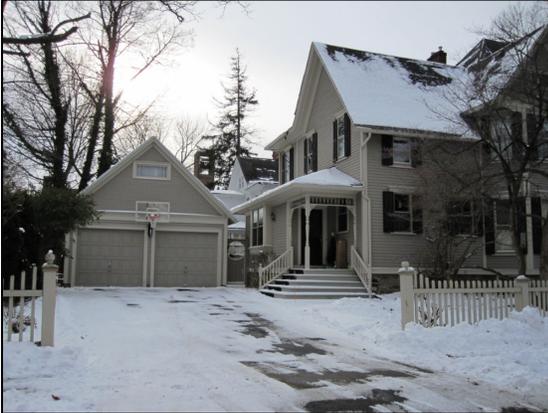
This garage incorporates a roof slope and unique gable detailing matching the adjacent Queen Anne style "Gomph" house.

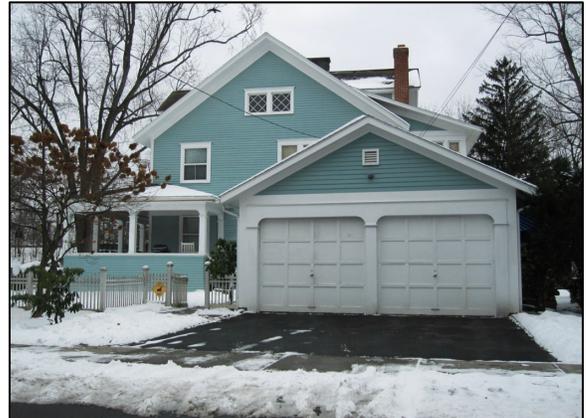
The garage of this house faces the side street. The rounded corners of the garage door openings mimic the porch column profile found on the house.

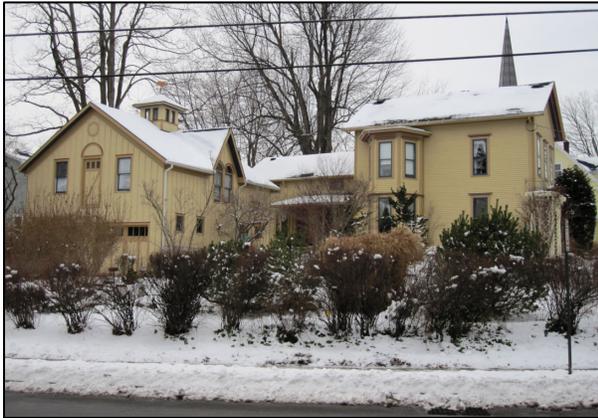
The garage next to this Italianate house was designed to recall a mid nineteenth-century carriage barn. Note the board-and batten siding, cross gable, cupola, and half-round windows.

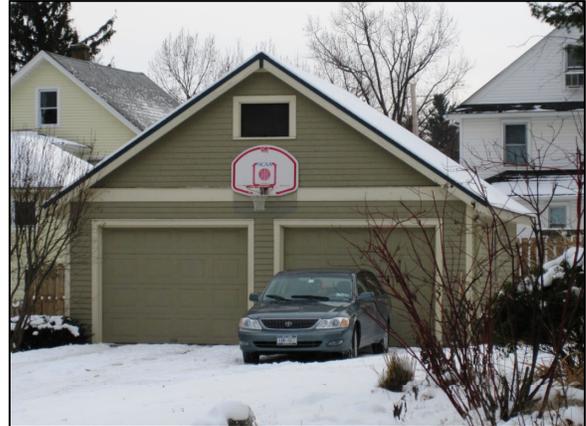
When an existing severely deteriorated single-car garage was replaced with a larger two-car structure, the form, roof slope, and trim details of the original were incorporated into the new design.
