SECTION 3

Historic Design Principles

General Principles of Historic Design

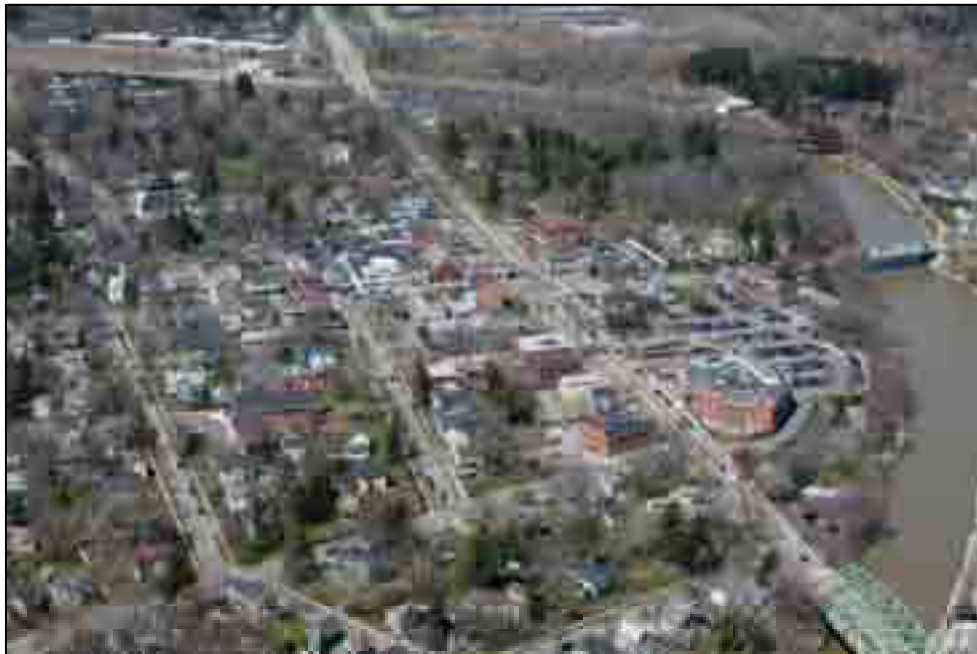
The Village of Pittsford is a dense cluster of buildings constructed during the last 200 years. Historic village buildings were constructed with a high level of craftsmanship and durable materials. A balance between architectural variety, consistency in proportion and other basic design principles has produced the village's pleasant historic character and visual harmony.

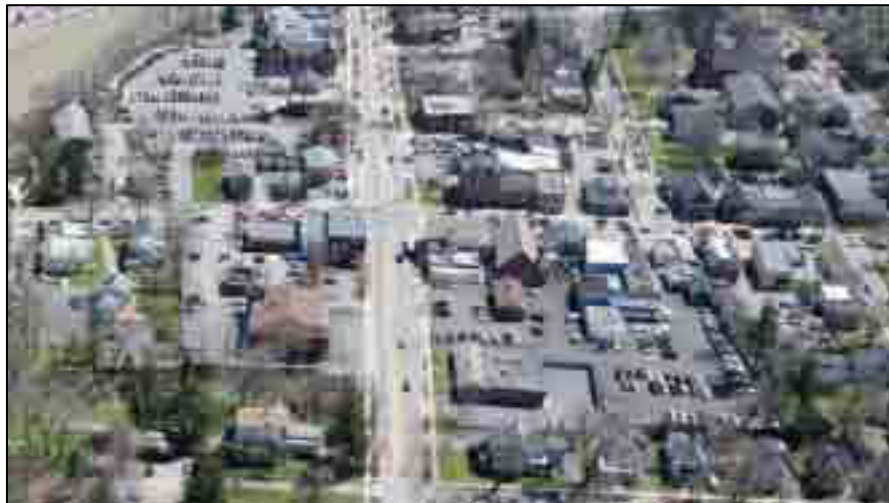
As this aerial view shows, buildings in the village are oriented with their main facade facing the street.

Location and Orientation: Village buildings face the street and visually relate to each other. They do not stand at an arbitrary angle to obtain a better view or to be invisible from the street. The village's residential and commercial neighborhoods are characterized by regular setbacks and spacing that creates a sense of visual unity. There are a few deviations that add to the eclectic nature and may define a certain period of development.

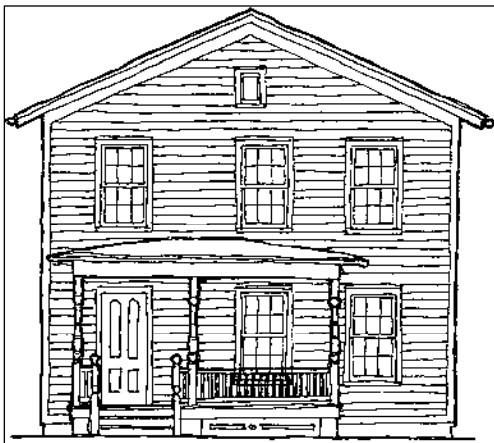
Compatible:
Maintain and preserve existing façade elements, including trim, window rhythm, details, and architectural features.

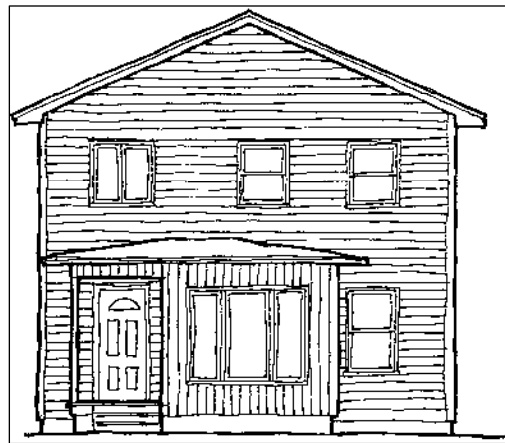
Incompatible:
Altering window size, location, or style
Enclosing an open porch
Removing architectural details

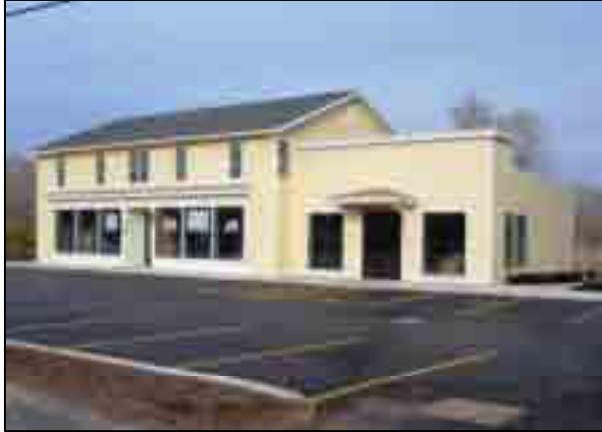
A former non-historic gas station was redesigned and enlarged in a simple style compatible with the neighboring utilitarian mills and barns in the Schoen Place waterfront district.

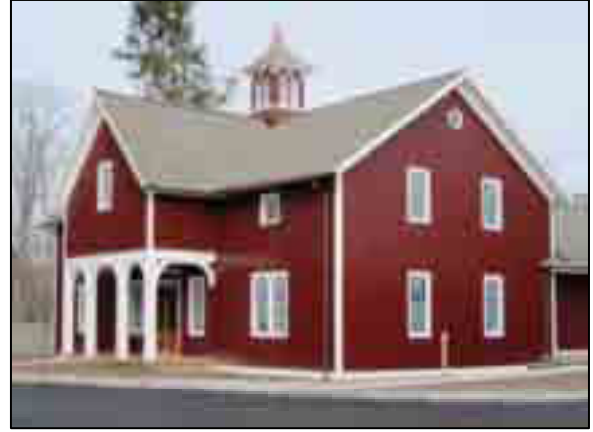
This dairy store and plant was designed to harmonize with the National Register listed farm on which it is located. The building's form, massing, roof slope, window style, and cupola relate to other structures on the property. The dairy's massing visually conceals the size of the modern plant and ensures the dairy does not visually compete with the historic main house. The building location was carefully selected to preserve historic views and landscape features and to conceal loading docks and other service elements.

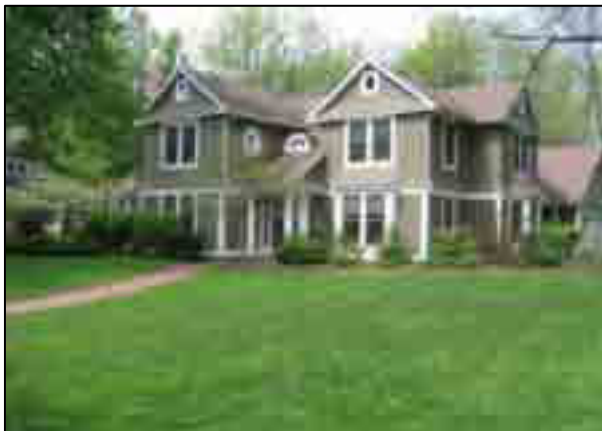
This large house employs setbacks, materials, and window proportions similar to neighboring older homes. The garage is discreetly tucked behind the house.

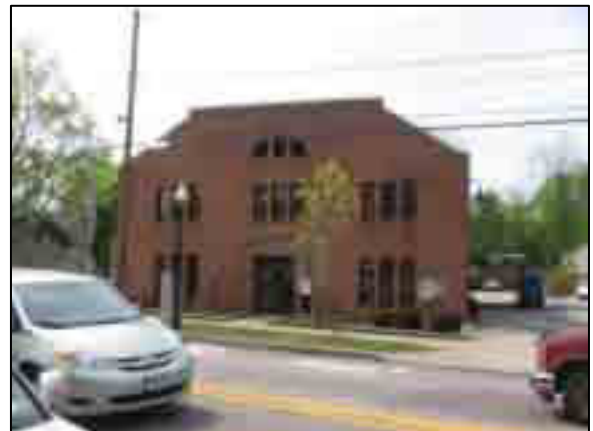
This bank shows how contemporary design can be blended with thoughtful consideration of scale, orientation, proportions and materials to produce a compatible building.

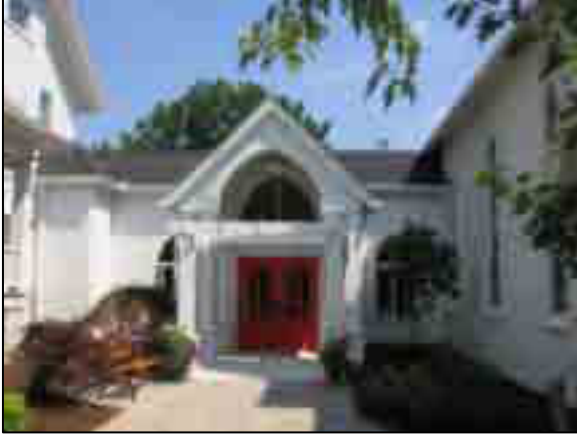
The new fellowship hall of Saint Paul's Lutheran Church matches materials and reinterprets architectural motifs found on the existing building.

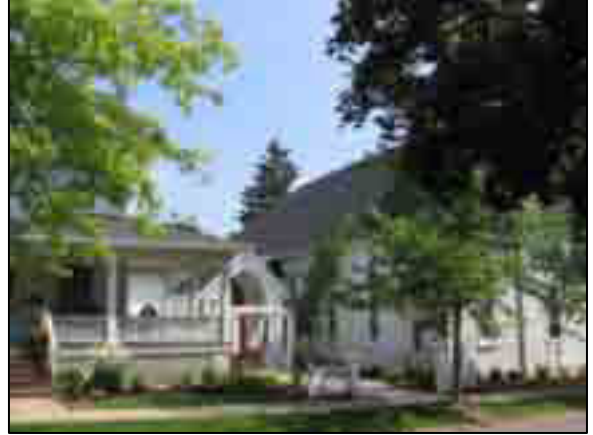
The Saint Paul's addition is set back from the two historic buildings it connects so it does not interrupt the rhythm of the street.

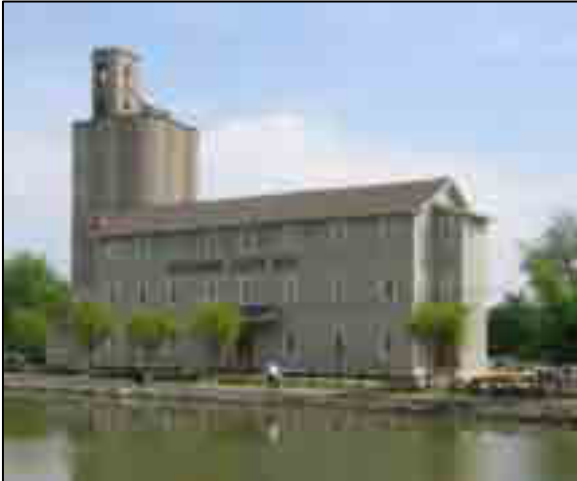
The small addition at the east end of the Pittsford Flour Mill houses mechanical equipment and a new entrance. The addition does not obscure any significant architectural features and is consistent with design of the historic building. It is small in relation to the original building. The entrance canopy is the reconstruction of a historic canopy whose appearance was documented by historic photographs.

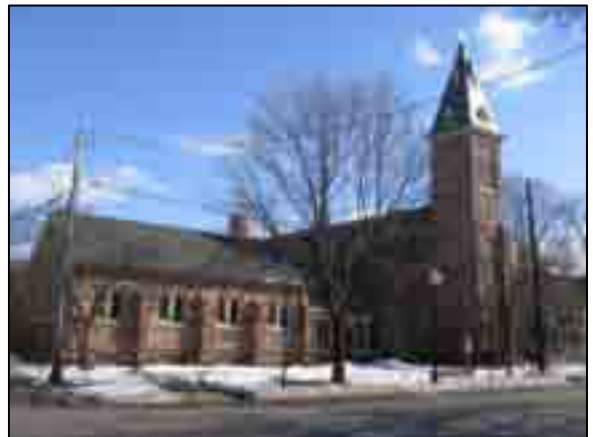
The wing was added to this Gothic Revival church over 100 years after the original building was built. By matching the exterior material (Medina sandstone) and architectural features, the wing harmonizes with the historic church. An articulated connection with lowered roof distinguishes the addition from the original building.

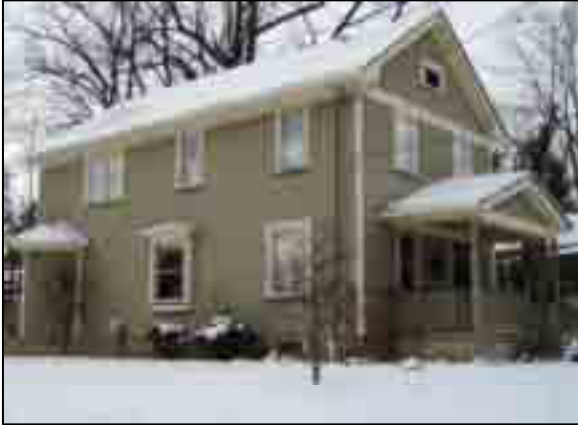
This Foursquare home has been enlarged with a compatible rear wing. A trim board identifies the limit of the original house.

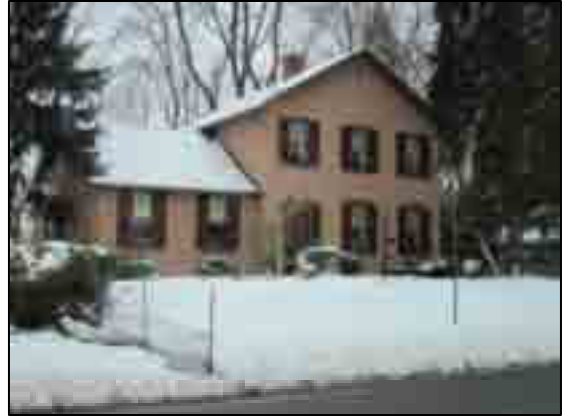
This mid nineteenth-century home has a new side wing. The wing matches the window size and other details of the original house. The main block with side wing massing is typical of mid nineteenth-century vernacular homes.

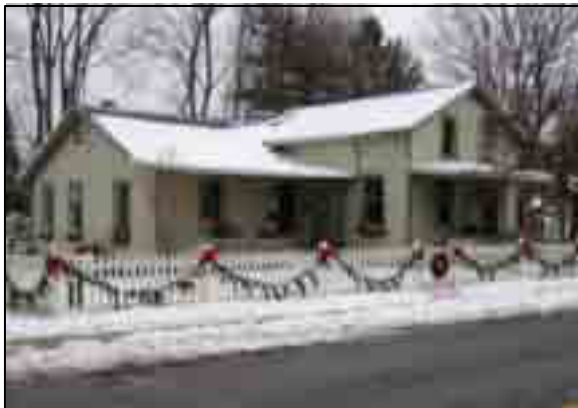
The wing added to this early nineteenth-century home matches the window design and spacing, porch details, and roof form of the original house.

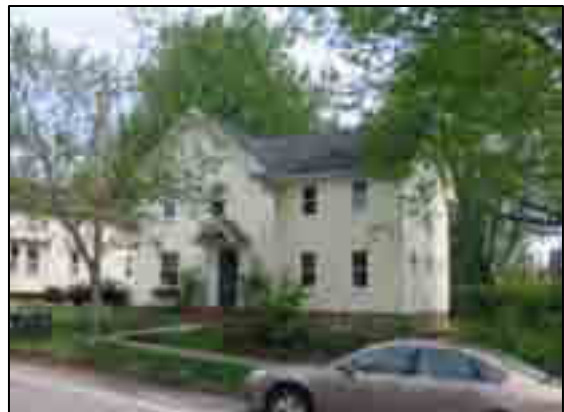
This ca. 1910 Four-square house was enlarged with a side wing. The wing respects the simple design, roof slope, window style, void-to-solid-ratio and proportions of the original house.

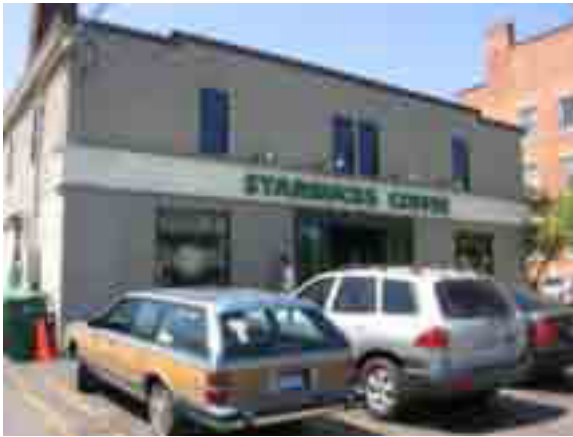
This ca. 1915 former garage was altered to accommodate a retail use. The original materials, including site-formed rock-face concrete block, were preserved. New elements, including the sign cornice and new windows, are visually compatible with the scale and period of the building.

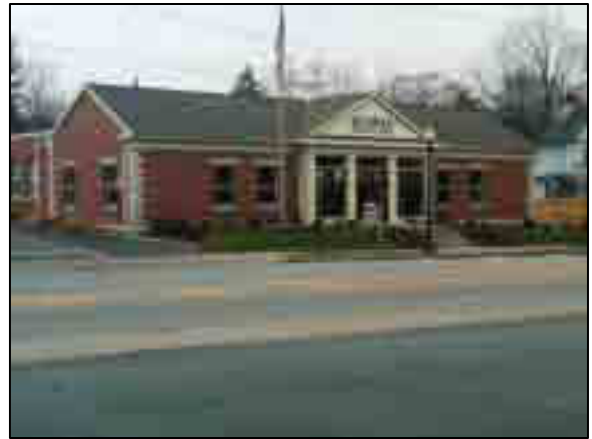
This ca. 1960 former post office was altered to provide a storefront for the current retail occupant. The design of the new entrance is in scale with the original building and uses elements that relate to the Postwar Colonial Revival style of the original building.

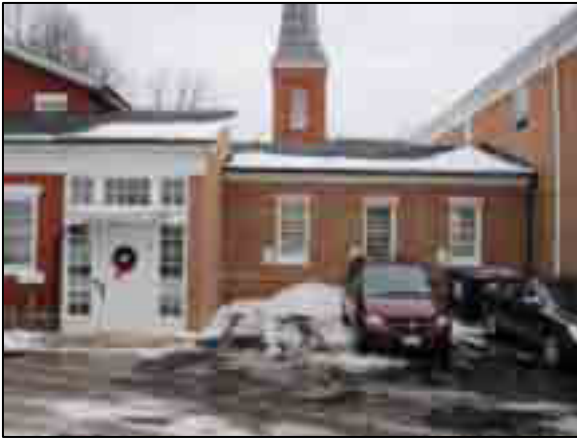
This handicapped accessible entrance provides access to the Guetersloh House (now church offices) and the Fellowship Hall of First Presbyterian Church. The entrance matches the scale of the house and is located at the rear of the building where it is not a visually prominent feature

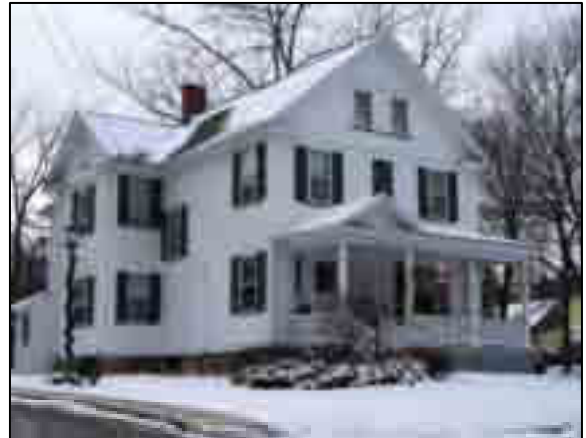
Blown-in insulation installed in this house caused catastrophic paint failure and deterioration of the exterior clapboard. After the owner investigated remedies with a preservation architect and failed to solve the problem, the owner applied to replace the original wood clapboard with cement fiber clapboard. The application was approved because the owner provided ample documentation investigating other unsuitable solutions and because the proposed material looked visually very similar to the material being replaced.

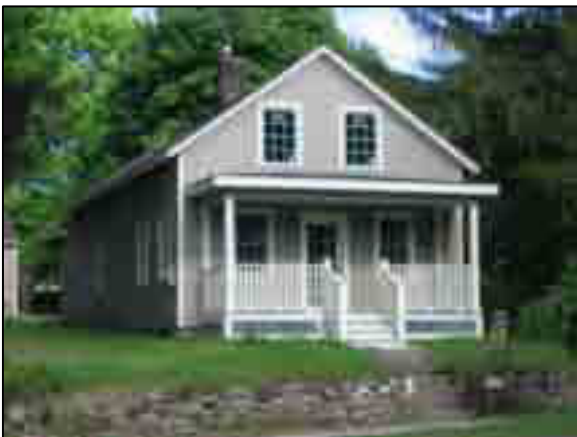
In remodeling this small home, the owner added a new porch and requested to install casement, rather than double-hung, second-floor windows to meet current NYS Building Code egress requirements. Because the new windows carefully match the proportions and muntin pattern of the windows in the rest of the house, the application was approved.

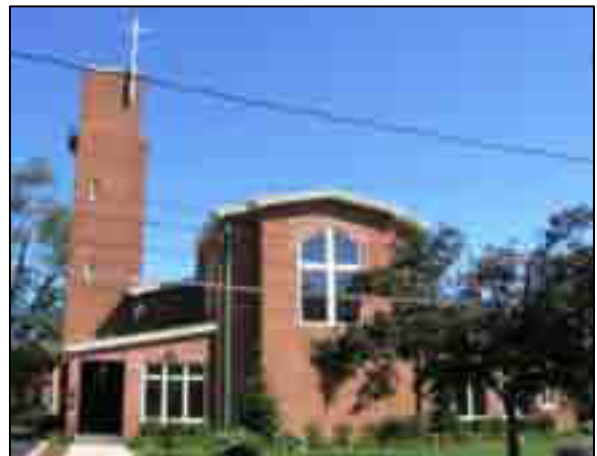
To address liturgical changes and provide more seating, Saint Louis Church remodeled the Main Street facade of the building. The church worked with the APRB to develop a solution that would not encroach into the viewshed of adjacent historic buildings and that respected the distinguished modern period design of the church.

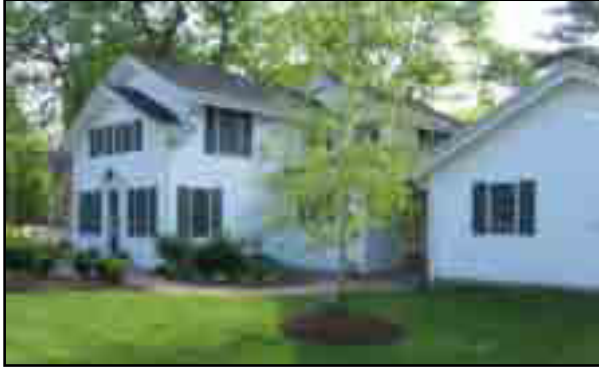
Additions have changed the scale and massing of this early nineteenth-century house. Replacement cladding and windows have made the exterior look flat and have eliminated historic trim details.

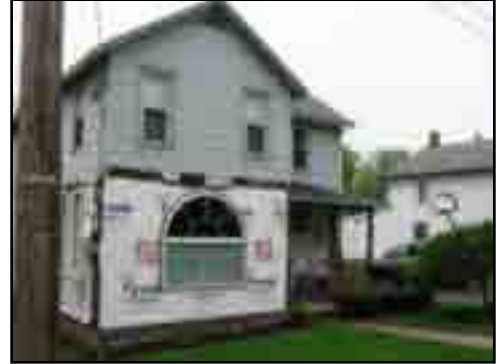
The new window added to this house is inappropriate in size, shape, proportion, and materials. Replacement porch components do not match the appearance of the original materials or design.

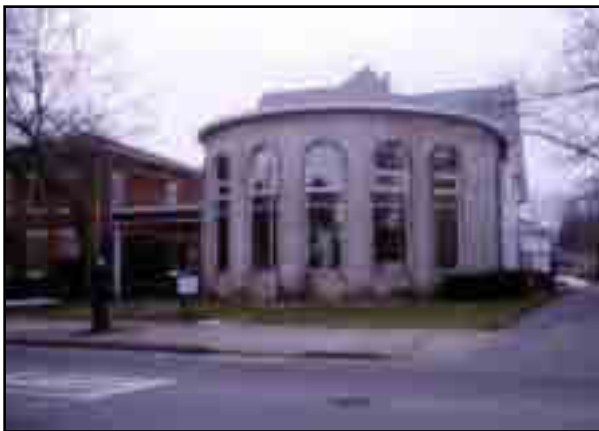
Everyone wants to “improve” their building. Today, very few contractors, and few architects, understand traditional materials or traditional design principles. The results can be disastrous as in the case above, where a large Colonial Revival home was hidden behind a grand “contemporary” façade. The scale, materials, form, massing and design of this addition are incompatible with the building and the neighborhood.

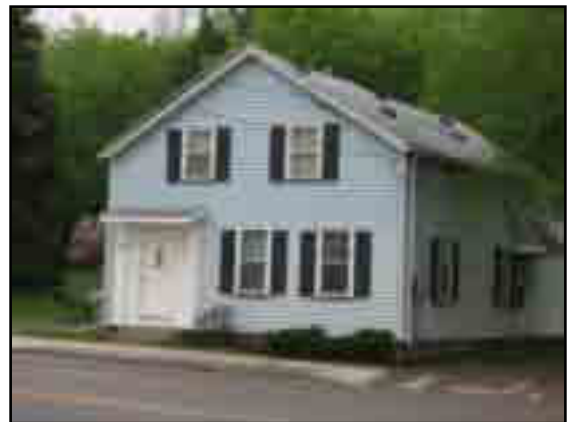
This early nineteenth-century Federal house has been stripped of its visual character by the installation vinyl siding, removal of the cornice returns, replacement of the original entrance and improperly mounted shutters. Compare the appearance of this house to the similar village of Pittsford house shown at the top of page 13.

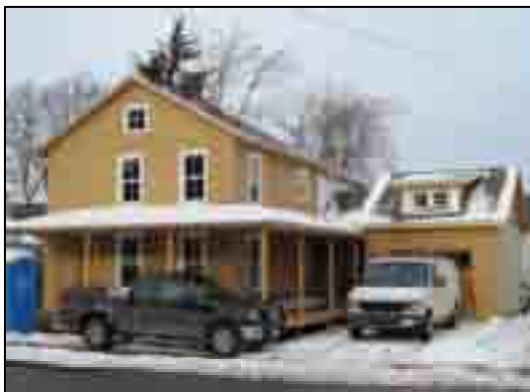
This home is one of the few village buildings the APRB has approved to relocate. The house was located on the village's smallest lot and severely deteriorated. The building had been previously moved and was set on an inadequate foundation that was accelerating the building's decay. By moving the building forward slightly on the same property, the owner was able to build a new foundation, add a garage at the rear, and expand the house with a small addition. The changes improved the house and the neighborhood.
